September 2015

Dealer Service Instructions for:

Safety Recall R36 / NHTSA 15V-459 Steering Wheel Wiring

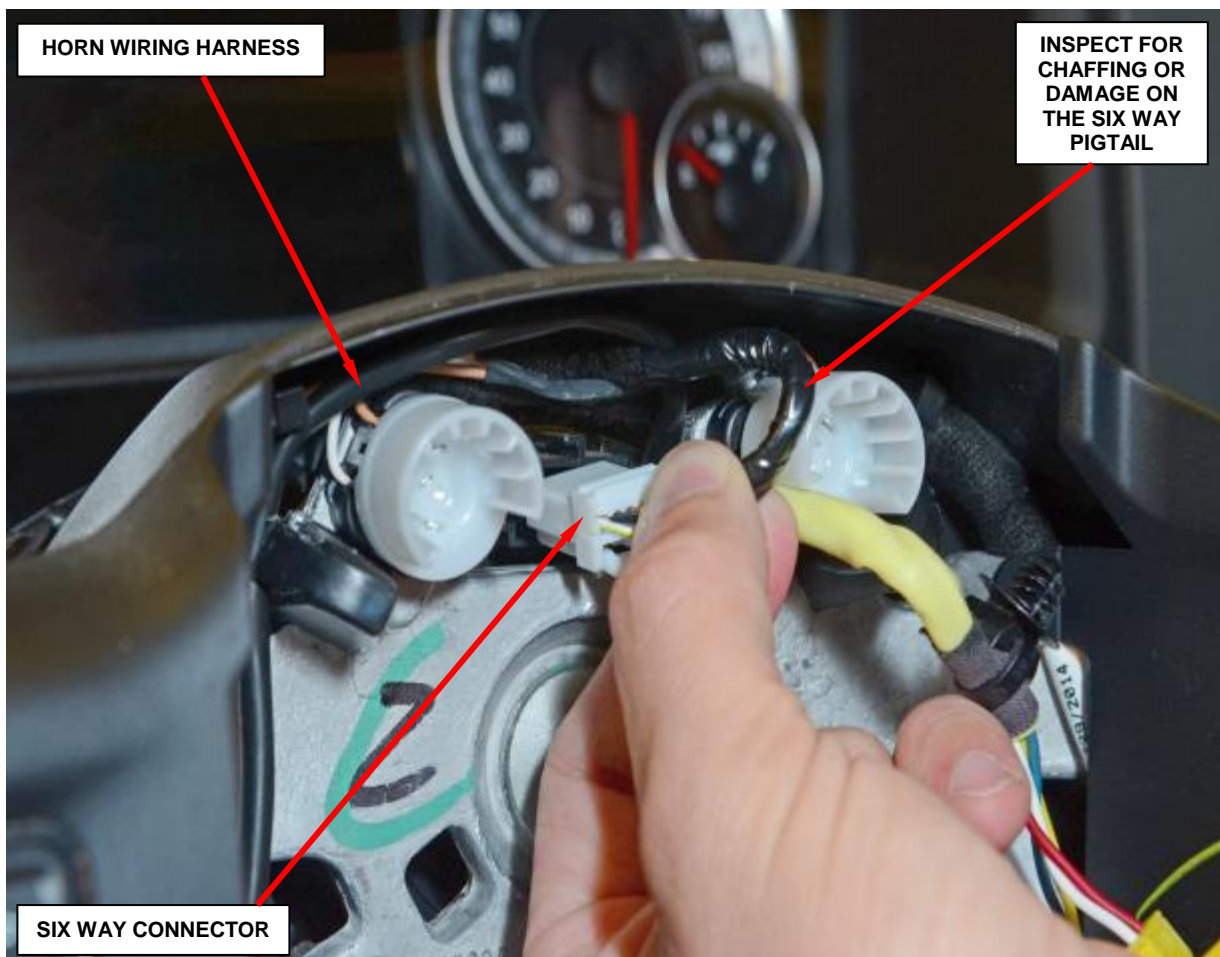
Figure 4 – Inspect For Wire Pigtail Damage

The steering wheel wire harness on about 1,060,000 of the above vehicles may become chaffed by the driver airbag module retainer spring ends. A chaffed steering wheel wire harness could cause an electrical short and/or an inadvertent driver airbag deployment. Inadvertent driver airbag deployment, during certain driving conditions, may increase the risk of a crash and/or vehicle occupant injury.

11. Disconnect the steering wheel wire harness six way connector (Figure 4).

12. Inspect the wiring harness for chaffing or damage on the six way pigtail and repair as necessary (Figure 4).

NOTE: If bare wire or chaffing is present, tape the wire using vinyl electrical tape.
