Dealer Service Instructions for:

Safety Recall S24 / NHTSA 16V-202 CAN-C Bus Connector

2015-2016 (VM) RAM ProMaster City

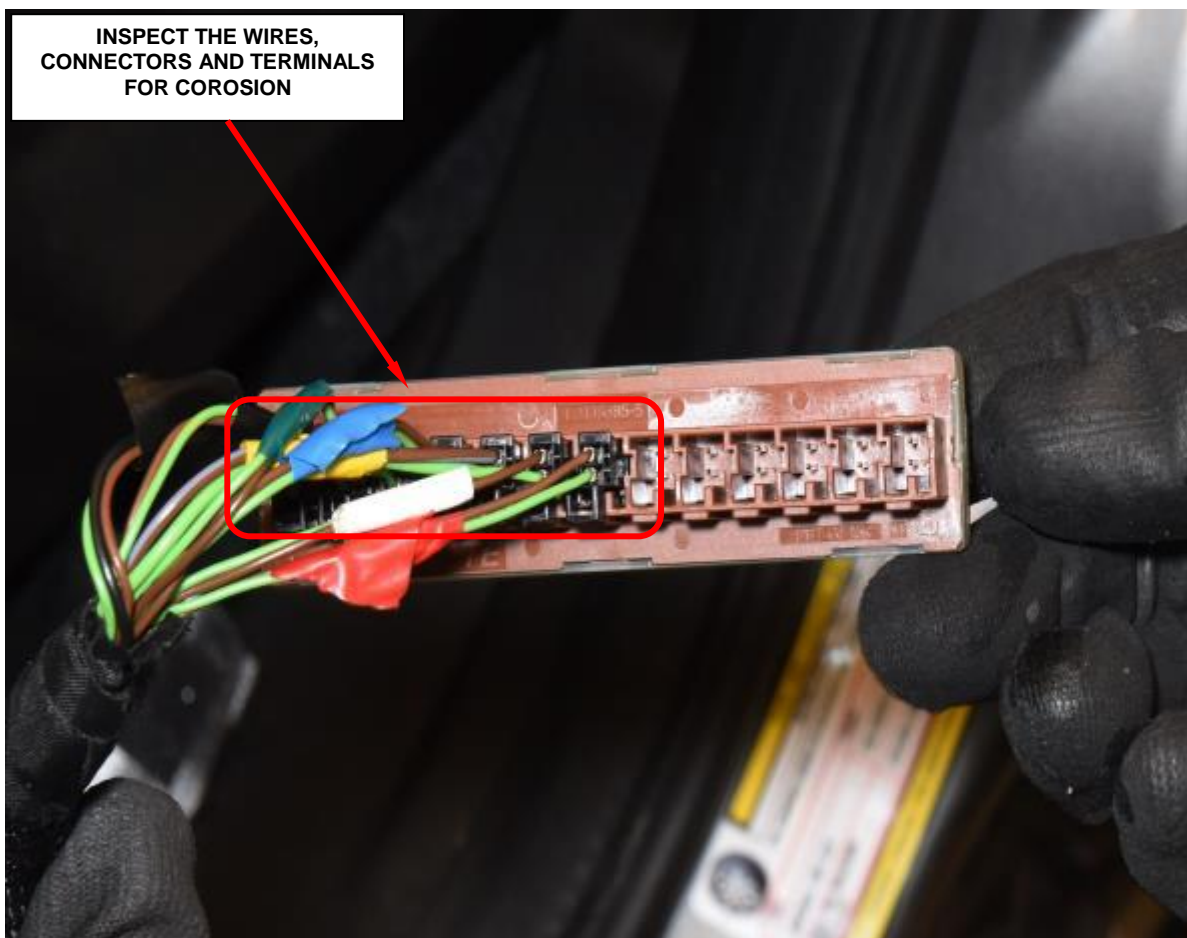
Figure 5 – Inspect for Corrosion

The CAN-C bus communication connector on about 23,900 of the above vehicles may develop internal connector pin corrosion due to moisture.

Corroded CAN-C bus communication connector pin(s) could lead to a loss of electrical contact and/or a loss of communication to the Transmission Control Module (TCM). A loss of communication to the TCM could cause the transmission to perform an unrequested shift into neutral. The vehicle operator would be unable to reengage the transmission. This could cause a crash without warning.

12. Inspect the CAN-C Bus Connector to assure there is no corrosion (Figure 5).

The CAN-C bus communication connector must be inspected for pin corrosion. Vehicles found with corroded CAN-C bus connector pin(s) must have the connector replaced.

- If corrosion **is** present, continue with **Section C. Replace CAN-C Bus Connector.**
- If corrosion **is not** present, continue with **Section B. Relocate CAN-C Bus Connector.**
