Dealer Service Instructions for:

Safety Recall S37 / NHTSA 16V-300 Third Row Seat Back

2016 (RT) Chrysler Town and Country

2016 (RT) Dodge Caravan

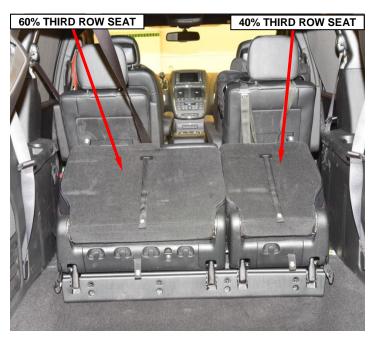
Figure 1 - Third Row Seat Backs Folded

1. Fold both third row seat backs forward (Figure 1).

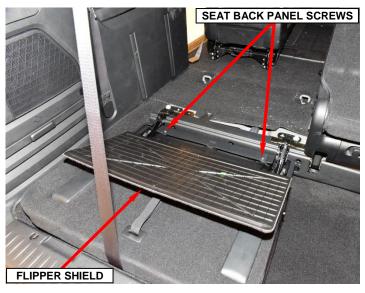
Figure 2 - Screw Access Under Flipper Shield

2. Stow the 60% third row seat and turn over the flipper shield to expose the bottom of the seat (Figure 2).

3. Remove and save the two screws from the third row seat back panel of the 60% seat (Figure 2).

- 15. Stow the third row 60% seat and turn over the flipper shield to expose the bottom of the seat (Figure 2).
- 16. Install and tighten the two screws securing the seat back panel to the back side of the third row 60% seat (Figure 2).

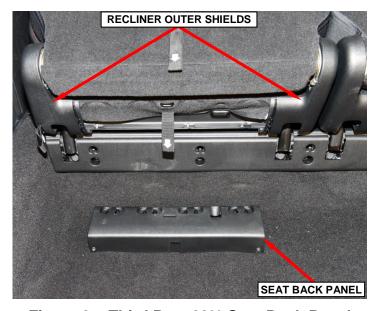
5. Remove and save the third row 60% seat back panel by pulling up from the bottom to release the panel from the

pulling up from the bottom to release the panel from the seat recliner outer shields (Figure 3).

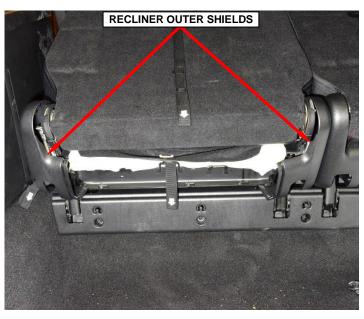
Figure 4 – Reposition Seat Recliner Shields

6. Release the third row 60% seat recliner outer shields from the right and left side recliners, positioning the shields slightly to the side (Figure 4).

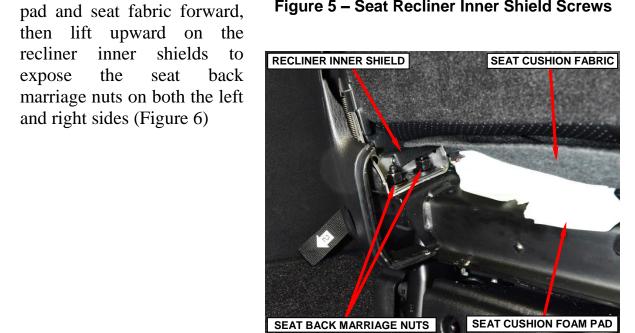
Figure 6 - Seat Back Marriage Nuts

The third row 60% side seat marriage nuts on about 90 of the above vehicles were not tightened properly during the manufacturing process. If the marriage nuts are not tightened to the proper torque specification, there could be a separation of the third row seatback frame assembly from the cushion frame assembly. Separation of the third row seatback frame assembly from the cushion frame assembly could increase the potential for third row seat occupants to be injured during a crash.

10. Using a 3/8 inch drive torque wrench with a crowfoot adapter matching the proper length dimensions, tighten the seat back marriage nuts to 31 ft. lbs. (42.5 N·m). Two nuts on right side and two nuts on left side, four nuts total. If a nut is missing, install a new nut (Figure 8).

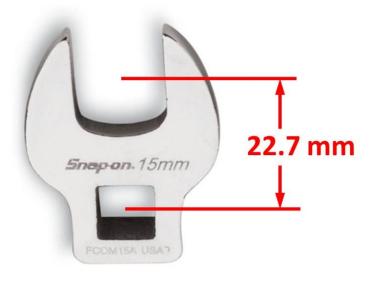
Figure 7 – Crowfoot Adapter Dimensions

9. Obtain a Snap-on 3/8 inch drive 15 mm open end metric crowfoot wrench (FCOM15A) or equivalent crowfoot wrench with similar length dimension in order to achieve the proper torque specification while tightening the seat back marriage nuts.

CAUTION: Using a crowfoot wrench of longer or shorter dimension will result in nuts that are either too tight or too loose which could result in separation of the third row seatback frame assembly from the cushion frame assembly.

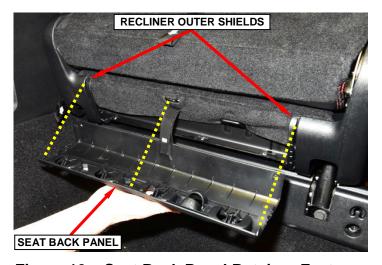
Figure 10 – Seat Back Panel Retainer Features

- 11. Move the seat cushion foam pad and fabric cover back into their original position.
- 12. Reposition the seat recliner inner shields then install and tighten the screws (Figure 5).
- 13. Reposition the seat recliner outer shields covering the right and left recliners (Figure 9).
- 14. Install the seat back panel by first engaging the three retainer features along the top edge of the panel. Then continue installing the panel while aligning the panel to the right and left seat recliner shields (Figures 10 and 11).

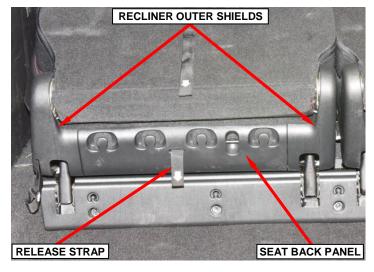
Figure 11 – Seat Back Panel Properly Installed

NOTE: Ensure the release strap passes through the slot in the seat back panel (Figure 11)

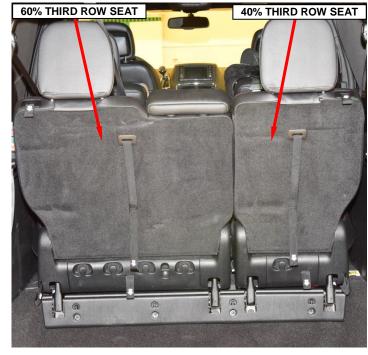
Figure 12 - Seat Backs In Upright Position

17. Unstow the 60% seat and place the rear seat backs of both third row seats in the upright position (Figure 12).

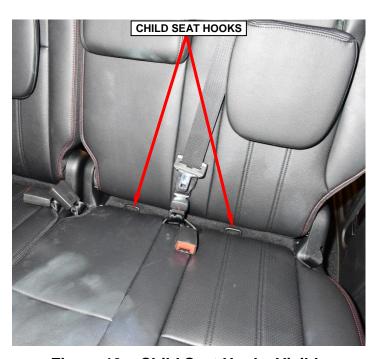
Figure 13 - Child Seat Hooks Visible

18. Inspect that the child seat hooks are visible and seat covering is properly positioned (Figure 13).
