October 2016

Dealer Service Instructions for:

Safety Recall S55 / NHTSA 16V-529 Transaxle Range Sensor Wire Harness

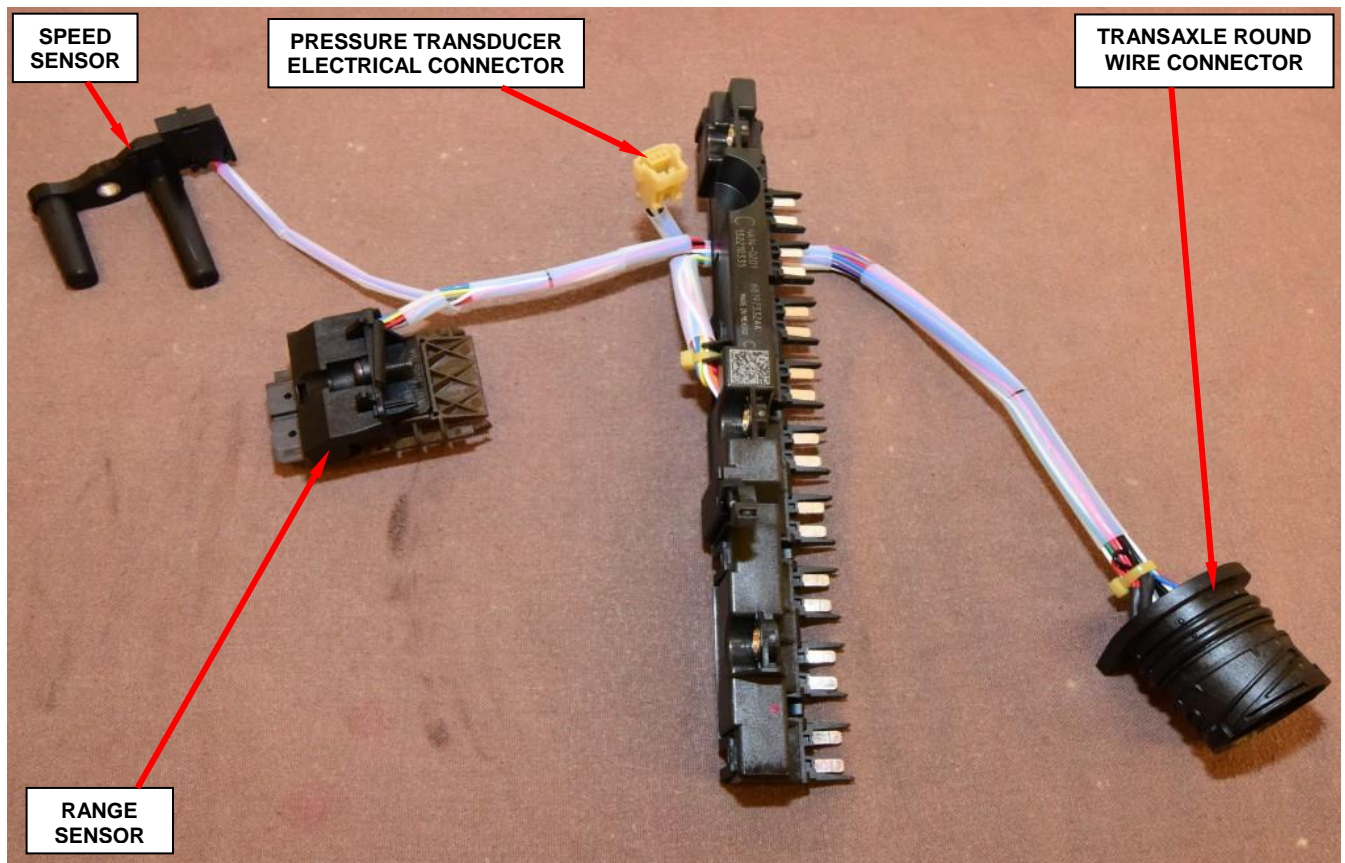
**Figure 8 – Transaxle Range Sensor Wire Harness**

The transaxle range sensor wire harness on about 323,400 of the above vehicles may have been built with insufficient wire terminal crimps. This may cause an intermittent high electrical resistance in the transaxle range sensor wire harness circuit(s). A high resistance circuit(s) in this transaxle range sensor wiring harness will cause the on-board diagnostic system to set a Diagnostic Trouble Code (DTC). When the DTC is set, the system defaults the transaxle to neutral and the customer experiences a loss of motive power. Motive power can usually be regained upon an engine restart. The loss of motive power could cause a crash without warning.

26. Remove and discard the original transaxle range sensor wire harness (Figure 8).
27. Place the new transaxle range sensor wire harness into position (Figure 8).
28. Install the three transaxle range sensor wire harness retaining screws (Figure 7). Tighten the screws to 50 in. lbs. (6 N·m).
29. Connect the electrical connector for the pressure transducer (Figure 8).
30. Replace both rubber O-rings on all the valve body fluid crossover tubes.
CAUTION: Be sure to lubricate the O-rings with clean transmission oil.
31. Loosely place the valve body into position on the transaxle.
32. For BU/FB models, lower the vehicle from the hoist.
