Dealer Service Instructions for:

Safety Recall U99 / NHTSA 18V-635 Coolant Hose

2018 - 2019 (GU) Alfa Romeo Stelvio Quadrifoglio

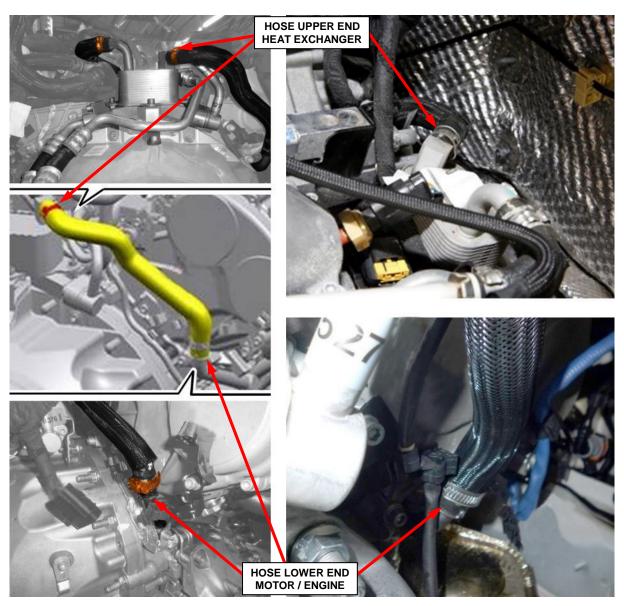
Figure 23 - Engine Coolant Hose

The engine cooling hose on about 660 of the above vehicles may have been manufactured with an inadequate inner webbing material, which may allow coolant to leak. Engine cooling hose leakage may result in a loss of coolant causing the engine to overheat. An overheated engine may result in a loss of motive power. Loss of motive power can cause vehicle crash without prior warning.

- 49. Remove and discard the clamps from both ends of the engine coolant hose between the engine water supply pipe to automatic transmission oil heat exchanger on the right side of the engine (Figure 23).
- 50. Remove and discard the engine coolant hose (Figure 23).

2. Install the new hose with clamps to the engine water supply pipe and the heat exchanger (Figure 23).
