TO: : Mercedes-Benz Dealer Principals, General Managers, Sales Managers, Service Managers, Parts Managers	FROM: Thomas Brunner, Department Manager, Vehicle Compliance and Analysis, Engineering Services
RE: Recall Campaign 2015 120002 Model 222, Model Year 2015 Replace Battery Charger for High-Voltage Battery	DATE: January 22, 2016

Campaign No. 2015120002, January 2016

SUBJECT: **Model 222, Model Year 2015**
Replace Battery Charger for High-Voltage Battery

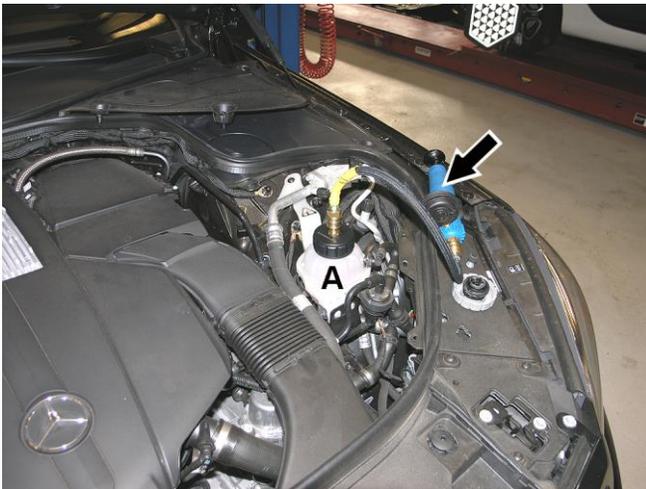
Figure 1

- Be sure to follow-on screen instructions in SDS when powering-down the high voltage system.
- When draining coolant from the battery charger supply pressure to low temperature coolant reservoir (A, Figure 1) using a pressure pump (arrow).
- **Contrary to WIS instructions do not replace locking nut (arrow, Figure 2) as it is attached to circuit 30 cable (1, Figure 2). Be sure to torque nut (arrow, Figure 2) to proper specification.**
- Save and reuse coolant previously drained from system.
- Remove 12V battery to allow clearance for removal of battery charger and DC/DC converter assembly; refer to WIS: AR54.10-P-0005LF.

Replace battery for high voltage battery; refer to WIS: AR54.10-P-5106LFH.
