TO: Mercedes-Benz Dealer Principals, General Managers, Sales Managers, Service Managers, Parts Managers	FROM: Thomas Brunner, Department Manager, Vehicle Compliance and Analysis, Engineering Services
RE: Recall Campaign 2016 100004 MY 2016-2017 Model 217 (S-Class Coupe/Cabriolet) Base Headlamp Adjustment	DATE: November 23, 2016

Campaign No. 2016100004, November 2016

SUBJECT: **Model 217, Model Years 2016 and 2017**
Check Left and Right Base Light in Low Beam Headlamp and Correct if Necessary

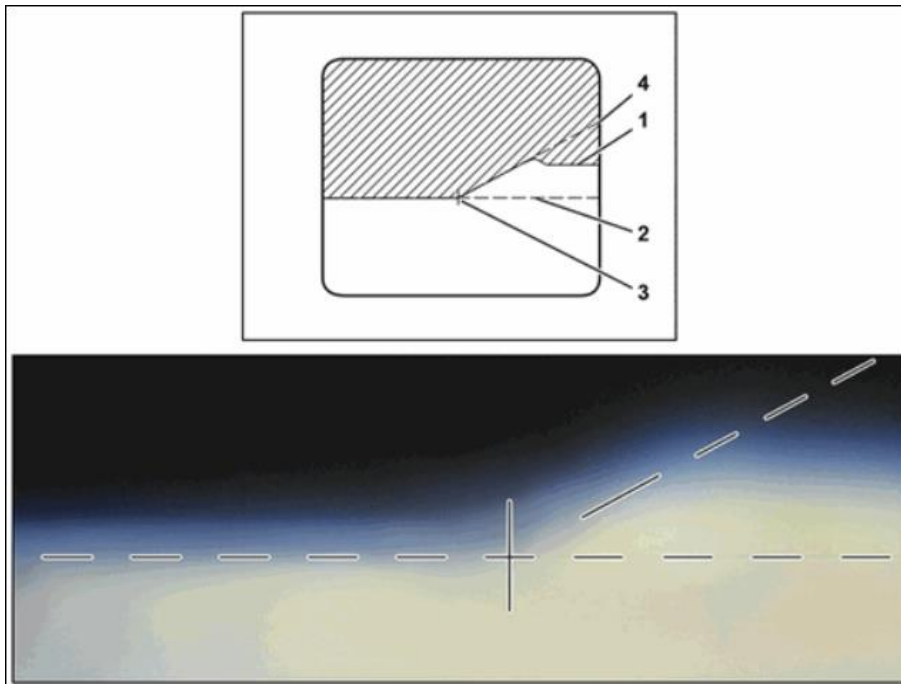
Figure 1

The side adjustment reference line (4, Figure 1) must pass through the central marking (3) of the height adjustment reference line (2).

Check level of right and left low beam; refer to WIS: AH82.10-P-1000-01A for general information on checking/correcting headlamp adjustment.
