02V-091

RECALL CAMPAIGN

REF. NO. 35
ENGINE GROUND STRAP

360 MODENA
360 SPIDER

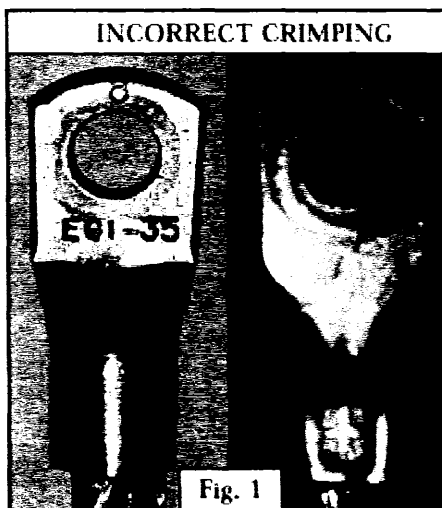
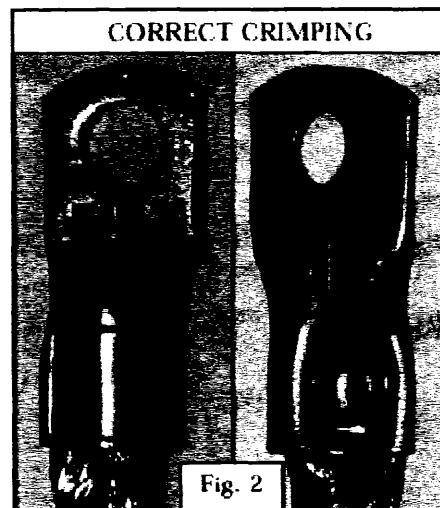
- Remove the underbody-fairing panel.
- Visually verify the engine ground strap connector crimping type (both ends).
- The **INCORRECT CRIMPING** of the ground strap connector is easily recognizable by the presence of a “**PLUS**” sign stamped on the connector. If one or both of the connectors have the presence of the stamping shown in **Fig. 1** (below), it is necessary to replace the engine ground strap with the new type shown in **Fig. 2** (below).
- If the engine ground strap has the correct type crimping (**Fig. 2** below), apply a dab of “red paint” to the ground strap mounting points to identify the updating.
- Replace the underbody-fairing panel, the recall is complete.
