Subject: FR-Series Bearing Spacer Inspection

Service Bulletin: TBD

Date: November 13, 2015

FR Bearing Spacer Inspection – Dealer Instructions

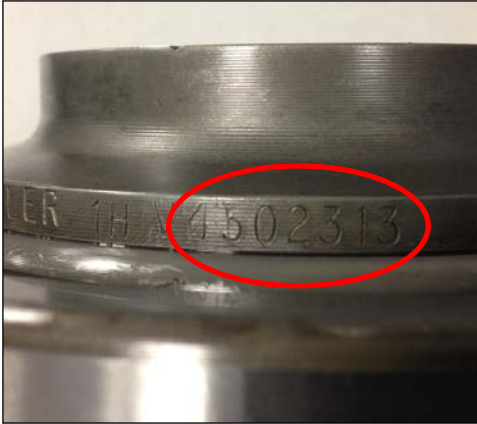
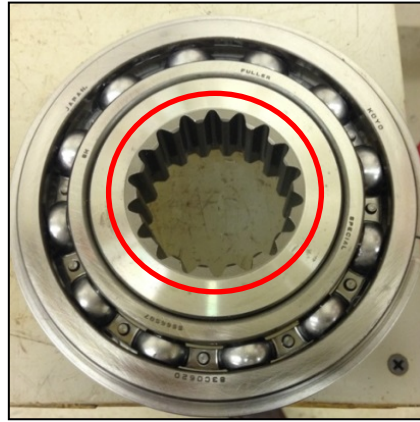
Correct Spacer 4302313:

- The part number is not printed on the machined face of the 4302313 spacer.
- All spline locations are populated on spacer.
- Example of the photos needed from the repairing dealer, one showing the internal splines and one showing the part number.

6. Eaton RTW will use the provided photos to verify if spacer is conforming before the transmissions is re-assembled.
7. If the bearing spacer is correct (See examples below), P/N **4302313** , reassemble transmission and close out the claim.

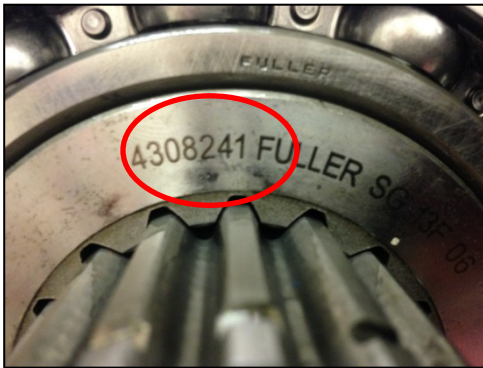
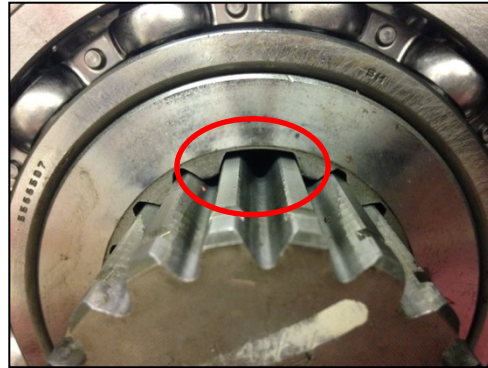
Incorrect Spacer 4308241:

Issue Description: A small group of FR-series transmissions were possibly built with an incorrect aux-driver gear spacer 4308241. This incorrect spacer forces the mainshaft key forward when installed and break the key. A broken key can allow the mainshaft reverse gear to move forward during operation, causing the transmission to be stuck in reverse gear with the shift lever in neutral.

- Part number 4308241 is visible on the spacer when the aux-drive gear is removed.
- One open spline on spacer.

8. If bearing spacer is incorrect (See examples below), P/N **4308241**, Eaton RTW will provide instructions to complete the repair and close out the claim.
