This Service Information bulletin supersedes SI 34 07 15 dated December 2015.

Recall 15V-882: DSC Hydraulic Unit System

I12 (i8)

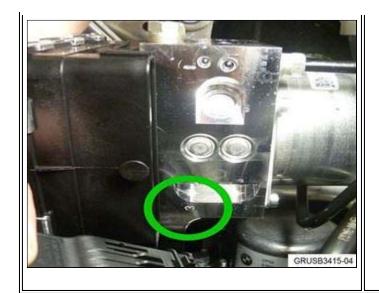
Due to a supplier error in the manufacturing process, the drill holes of one or more of the six pump pistons may not have been produced to specification. As a result, this could cause one or more pistons to become restricted. If this occurred, it could lead to impairment of the DSC functions, including the braking function. As a result, vehicle handling and control could be affected, increasing the risk of a crash.

4. 4. Check the number stamp on the pump block (where shown):

Is the pump block stamped with the number 2?

5. 5. Replace the DSC hydraulic unit; see Repair Instructions REP 34 51 527.
