PRODUCT CAMPAIGN BULLETIN

APPLICABILITY: 2016-2017MY Legacy and Outback

SUBJECT: Inspection and Repair Procedure
 for Stop Sale / Recall Campaign
 WTD-65: Steering Column

NUMBER: WTD-65

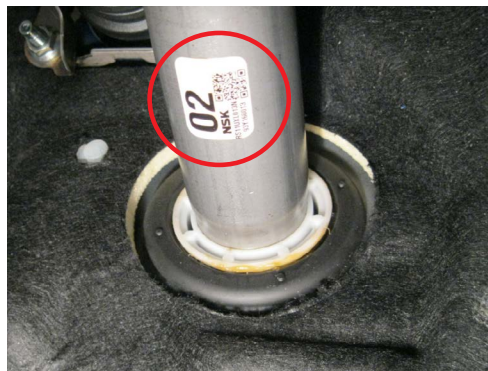
- Locate the lot number label at the base of the steering column located just above the toe board grommet as shown in the photo below.

For KEY START models, the label will have a large “02” as shown in the photo.

For PUSH START models, the label will have a large “03”.

The steering columns are **NOT** interchangeable.

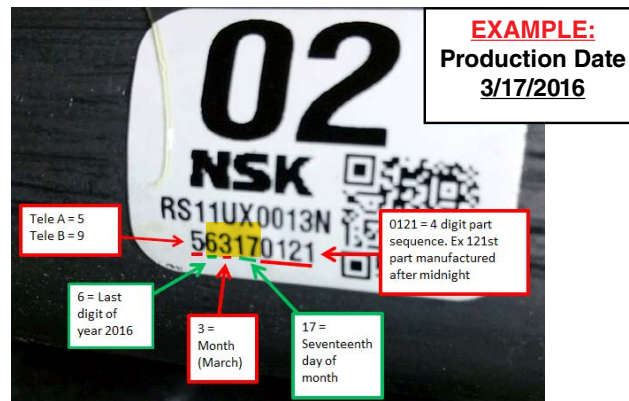
- Decode the lot number of the steering column using the illustration below.
- Affected steering columns will have a lot number label indicating the column was produced **on or between** 6228 (February 28, 2016) and 6416 (April 16, 2016), the steering column assembly must be replaced.
- If the lot number is illegible or otherwise cannot be determined, it must be noted on the repair order and the steering column assembly must be replaced.

- **IMPORTANT:** Always record the original lot number on the Repair Order even if it is outside the affected range. The **ORIGINAL** 4-digit lot number must also be entered in the Miscellaneous Detail field when submitting for claim reimbursement. If illegible, enter **“ILLEGIBLE”** in that field.
