Reference:

ITB16-022

VOLUNTARY SAFETY RECALL CAMPAIGN 2014 – 2016 Q50 AND Q50 HYBRID DIRECT ADAPTIVE STEERING SYSTEM SOFTWARE UPDATE

CAMPAIGN ID #: R1610

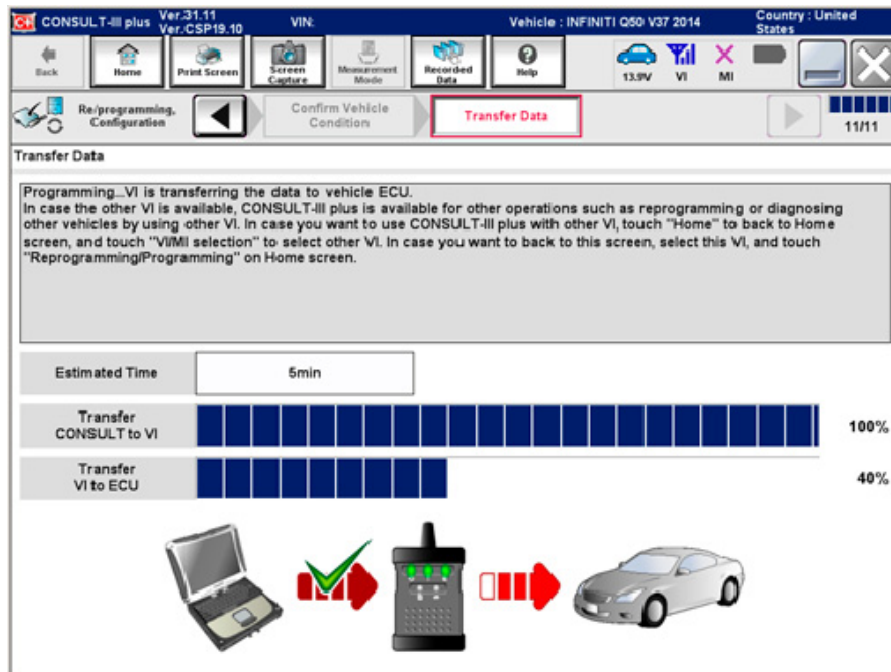
Figure 15

Possible errors that may rarely occur:

- If the progress bar freezes at 90% of a complete transfer to the plus VI and error code "12-1-1NR" is displayed (see Figure 16 on the next page), **turn the ignition OFF, then ON**, and then refer to **Control Unit Recovery** on the next page.
- If the progress bar freezes at 90% more than 3 times "on the same DAST control unit" but without Error Code "12-1-1NR", the DAST control unit that is currently being reprogrammed will need to be replaced.

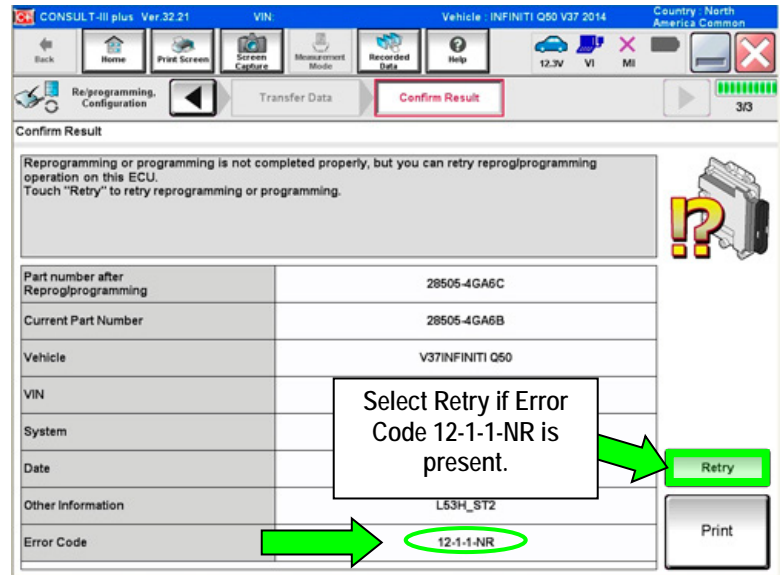
Figure 16

If reprogramming does not complete and the “!?” icon displays as shown in Figure 16:

- Check battery voltage (12.0–13.5 V).
- Ignition is ON, engine OFF (not READY).
- External Bluetooth® devices are OFF.
- All electrical loads are OFF.
- Select retry and follow the on screen instructions.
- “Retry” may not go through on the first attempt and can be selected more than once.

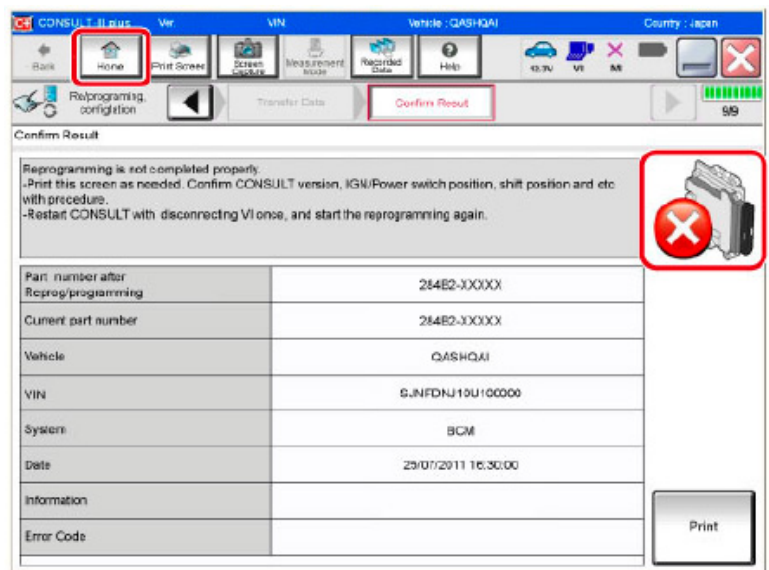
Figure 17

If reprogramming does not complete and the “X” icon displays as shown in Figure 17:

- Check battery voltage (12.0 – 13.5 V).
- CONSULT A/C adapter is plugged in.
- Ignition is ON, engine OFF (not READY).
- Transmission is in Park.
- All C-III plus / plus VI cables are securely connected.
- All C-III plus updates are installed.
- Select Home, and then restart the reprogram procedure from the beginning.
