## **PILKINGTON NORTH AMERICA, INC. PART 573 DEFECT REPORT**

January 14, 2016

This report serves as Pilkington North America, Inc.'s ("PNA's") notification to the U.S. Department of Transportation, National Highway Traffic Safety Administration that a defect related to motor vehicle safety exists in the bracket mounted on the inside of a small number of replacement windshields. These replacement windshields are used in the Mazda CX-5. On a small number of parts, a bracket installed on the inside of the windshield may have been affixed improperly. This bracket is used to hold a separate laser sensor or LIDAR device that is linked to the vehicle's Smart City Brake Support System. On or about January 8, 2016, PNA decided that there was a defect in the bracket or, more specifically, in the method used to affix the bracket to the inside of the windshield.

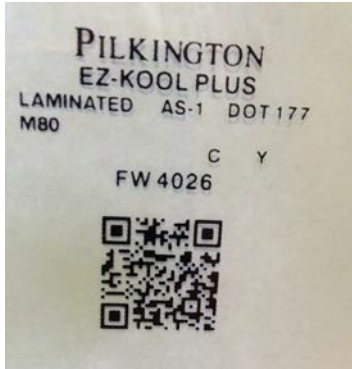
Type of equipment (e.g., tire, child restraint, headlamp): <b>Bracket installed inside replacement windshield; bracket used to support separate radar sensor or LIDAR device</b>
Part/Model number: <b>FW04026 GTY (NAGS Identifier)</b>
Size and function (where applicable): <b>The bracket was installed on replacement front windshields made as replacement parts for the Mazda CX-5</b>
Inclusive dates of manufacture (month and year): <b>These brackets were installed on windshields manufactured on particular days in November and December of 2015.</b>
Other information necessary to describe this equipment: <b>These replacement windshields are used only on the Mazda CX-5. Each windshield has a monogram with the Pilkington name and the phrase "EZ-Kool Plus." The DOT number is 177. The month code is "C" for November or "V" for December; and the year code is "Y" for 2015. A copy of the monogram for the November production days is shown below:</b>

Describe how the recall population is different from any similar items of equipment not subject to this notification: **The recall population has the DOT number of 177 (referring to the Mexicali plant). These windshields have the part number FW 4026. These windshields also have production date codes of either “C Y” or “V Y.” The affected windshields all have visible monograms with the “C Y” or “V Y” date codes.**
