# Program Bulletin

**SB-10032328-1094**

## CUSTOMER SATISFACTION PROGRAM

**SUBJECT:** Material Over Sensing and Diagnostic Module Retaining Moisture

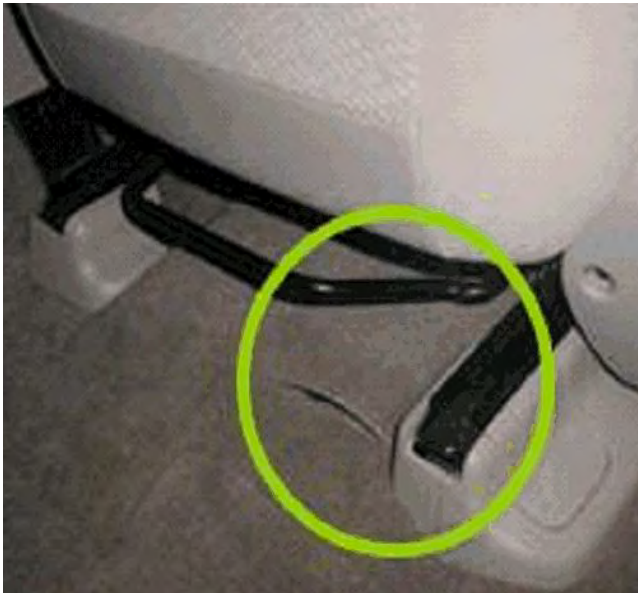
2348430

3. Move the driver's seat to the full forward or rearward position.

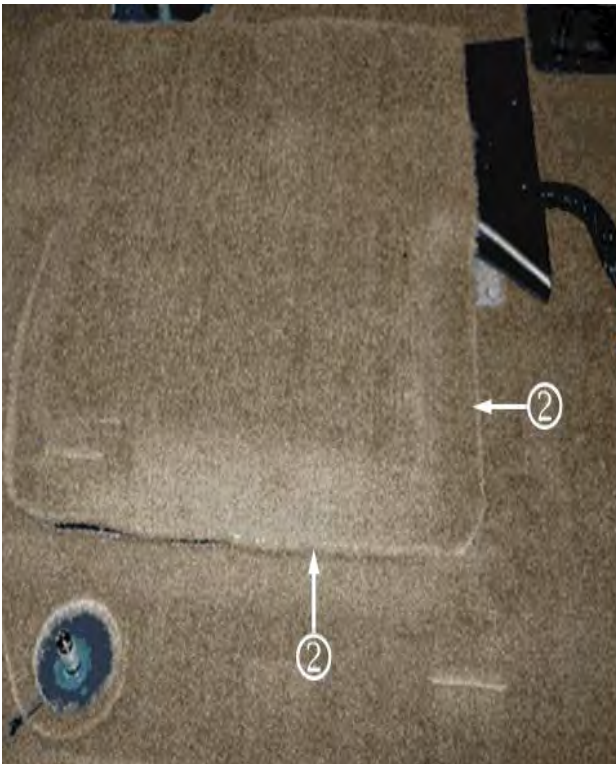
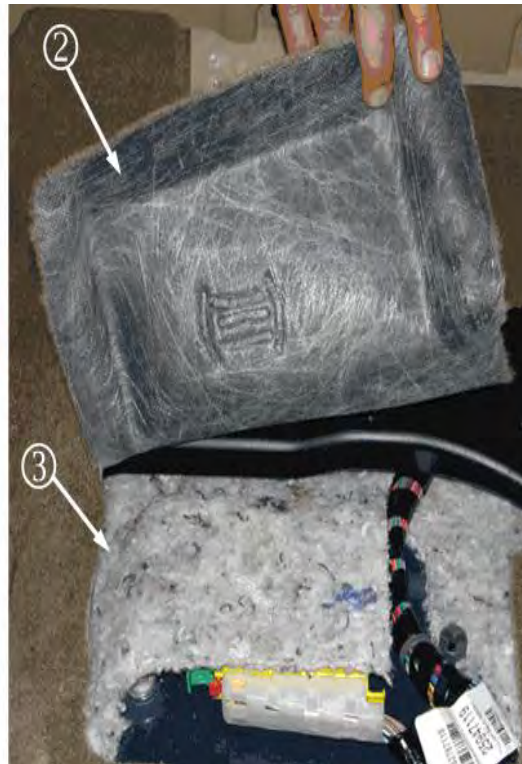
2348426

Carpet and cutout flap (2) shown with the driver's seat removed from the vehicle for illustration purposes only. Seat removal is NOT required to gain access to the acoustical pad (3).

**Note:** If there is no cutout flap or slit on the vinyl flooring, no further action is required unless the SDM requires replacement. If the vehicle is equipped with vinyl flooring with a slit only, insert your hand into the slit and tear out all of the acoustical pad (3) over the top of the SDM.

4. Lift the cutout flap (2) in the carpet or vinyl to gain access to the acoustical pad (3) that covers the SDM.

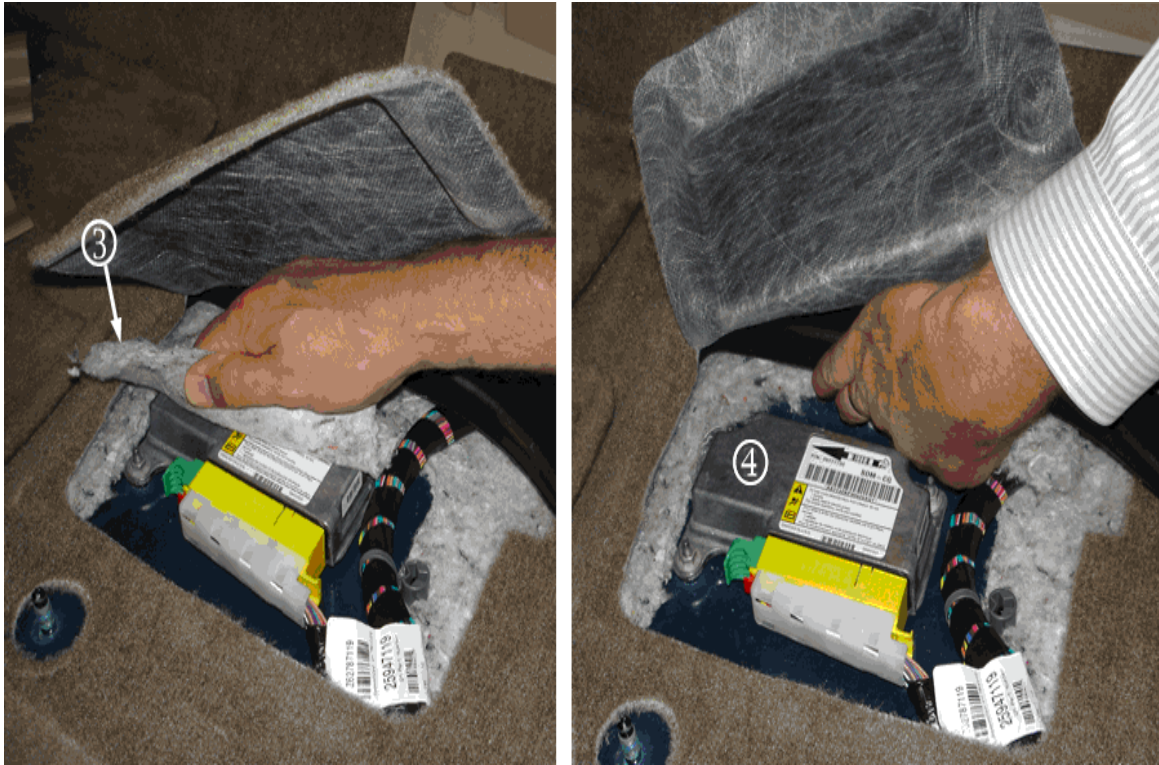
2348426

Seat removed for illustration purposes only

5. Using your hand, tear away and remove the acoustical pad (3) that covers the SDM (4). Ensure that no acoustical pad remains over, or in contact with, the SDM (4).
  - If SDM replacement is NOT required proceed to step 8.
  - If SDM replacement is required, proceed to steps 6-7.

6. Remove the SDM. Refer to *Airbag Sensing and Diagnostic Module Replacement* in SI.
7. Install a new SDM. Refer to *Airbag Sensing and Diagnostic Module Replacement* in SI.
8. Lower the carpet or vinyl cutout flap over SDM (4) and adjust the driver's seat to the customer-desired position.
