# Program Bulletin

## CUSTOMER SATISFACTION PROGRAM

**SUBJECT:** Material over Sensing & Diagnostic Module Retaining Moisture

**MODELS:** 2007-2009 Chevrolet Silverado  
2007-2009 GMC Sierra

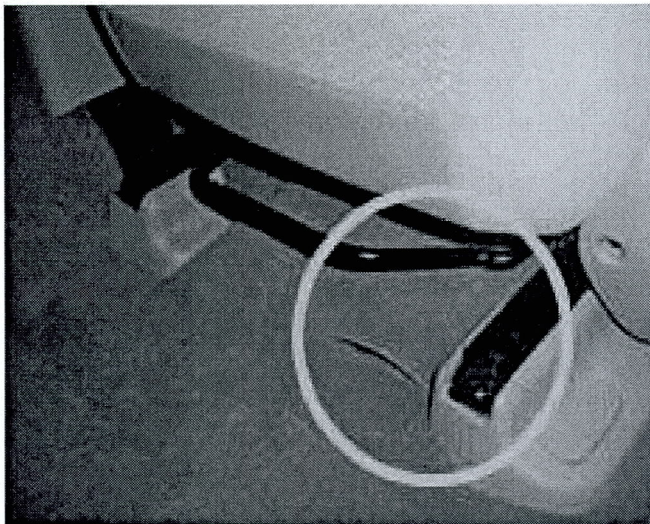
2348430

**Note:** Driver seat removal is NOT required for crew cab or extended cab vehicles. Certain 2009 regular cab vehicles built after approximately March 1, 2009 with carpet that has a 2-sided cutout over the SDM, however, will require driver seat removal. Refer to *Front Seat Replacement-Bucket* in SI. After the seat removal, proceed to Step 2 in the bulletin. Regular cab vehicles with carpet that has a 3-sided cut over the SDM do NOT require seat removal.

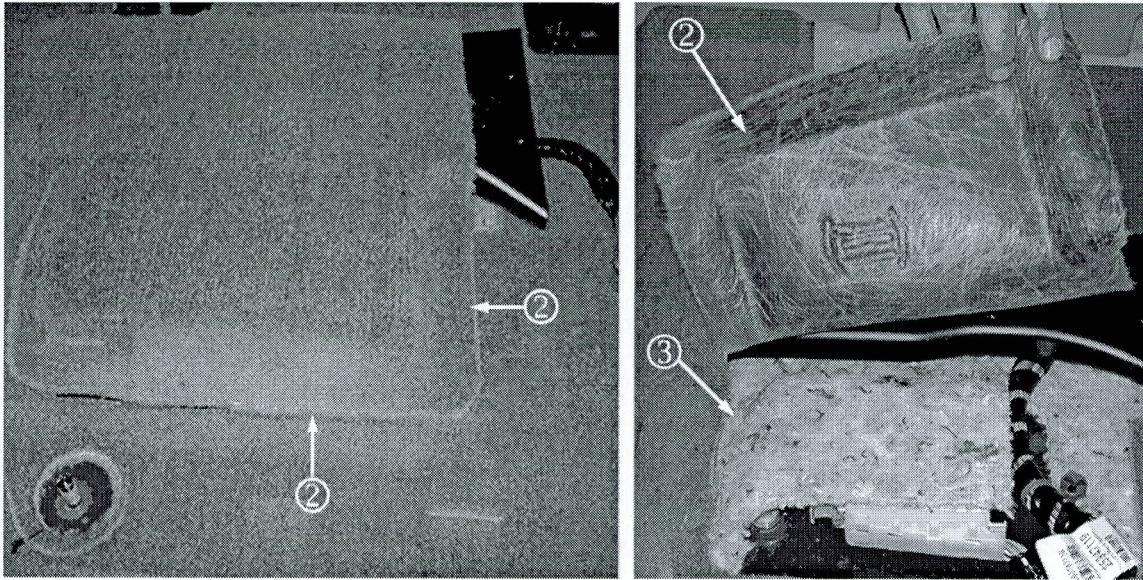
2348422

Carpet and cutout flap (2) shown with the driver's seat removed from the vehicle for illustration purposes only. Seat removal is NOT required to gain access to the acoustical pad (3).

3. Lift the cutout flap (2) in the carpet or vinyl to gain access to the acoustical pad (3) that covers the SDM.

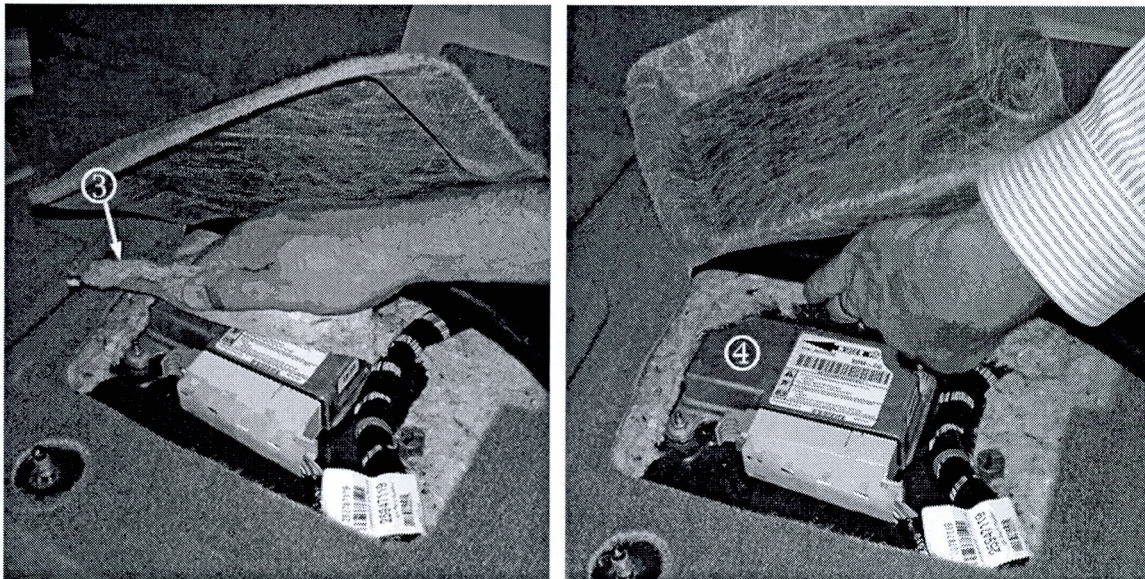
2348426

Seat removed for illustration purposes only.

4. Using your hand, tear away and remove the acoustical pad (3) that covers the SDM (4). Ensure that no acoustical pad remains over, or in contact with, the SDM (4).
5. Lower the carpet or vinyl cutout flap over SDM (4) and adjust the driver's seat to the customer-desired position.
