Service Bulletin

SPECIAL COVERAGE

SUBJECT: Special Coverage Adjustment – Ignition Key Removal

**MODELS: 2005-2006 Chevrolet Equinox
2006 Pontiac Torrent
2005-2007 Saturn VUE**

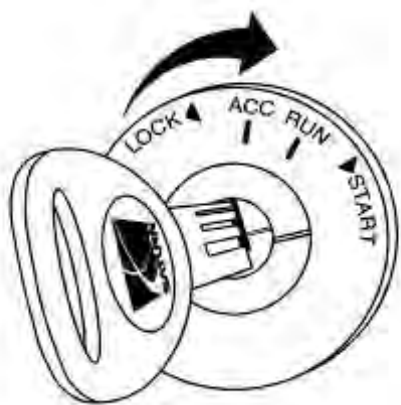
1334808

Note: Some Saturn VUE vehicles may have a condition in which the ignition key can be removed when the ignition is NOT in the LOCK position.

Note: With the key in the ignition switch, you can turn it to four different positions. **You should only be able to remove the key when the ignition is turned to the LOCK position.** Below is a description of the four ignition positions:

1. Determine if the key can be removed from the ignition cylinder in any position other than the LOCK position.
 - If the key **cannot** be removed in any position other than the LOCK position, no further action is required.
 - If the key can be removed from the ignition cylinder while in the ACC, RUN or START position, replace the ignition lock cylinder and key set (2 keys). Proceed to step 2.
2. Remove the ignition lock cylinder. Refer to *Ignition Lock Cylinder Replacement* in SI.
3. Install a new ignition lock cylinder. Refer to *Ignition Lock Cylinder Replacement* in SI.

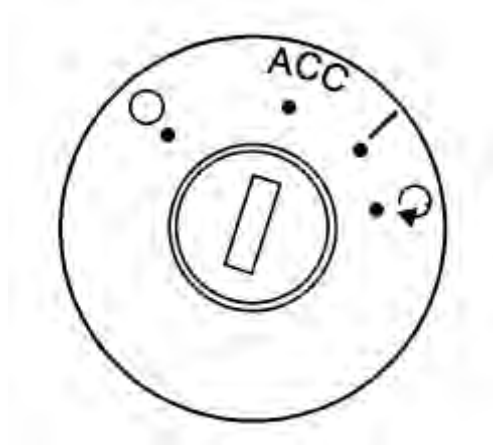
1839823

Note: Some Chevrolet Equinox and Pontiac Torrent vehicles may have a condition in which the ignition key can be removed when the ignition is NOT in the LOCK position.

Note: With the key in the ignition switch, you can turn it to four different positions. **You should only be able to remove the key when the ignition is turned to the LOCK position.** Below is a description of the four ignition positions:

1. Determine if the key can be removed from the ignition cylinder in any position other than the LOCK position.
 - If the key **cannot** be removed in any position other than the LOCK position, no further action is required.
 - If the key can be removed from the ignition cylinder while in the ACC, RUN or START position, replace the ignition lock cylinder and key set (2 keys). Proceed to step 2.
2. Remove the ignition lock cylinder. Refer to *Ignition Lock Cylinder Replacement* in SI.
3. Install a new ignition lock cylinder. Refer to *Ignition Lock Cylinder Replacement* in SI.
