Service Bulletin

SUBJECT: Special Coverage Adjustment – Engine Coolant Leak from the Water Pump

**MODELS: 2011-2014 Chevrolet Cruze
2012-2014 Chevrolet Sonic
With 1.4L Engine (RPO LUJ or LUV)**

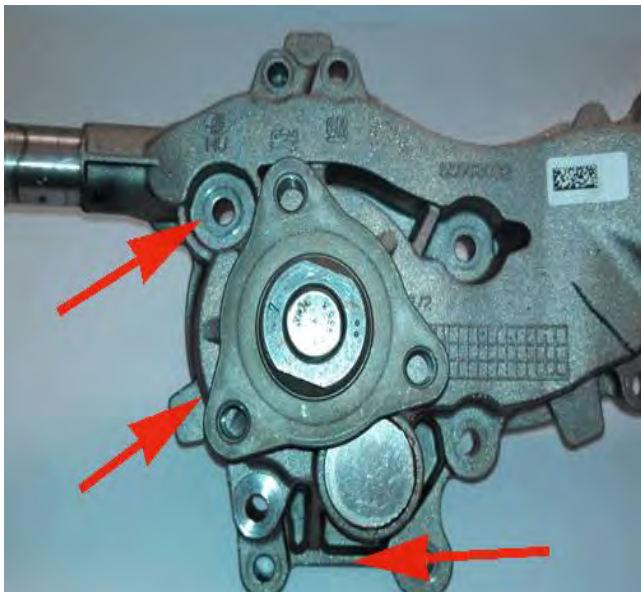
3609232

Normal Water Pump Appearance (Do Not Replace Pump)

No evidence of coolant leakage on the pump body.

If the water pump is not obviously leaking and the housing only shows minimal coolant deposits as shown below, do not replace the pump. The water pump is functioning as designed and no further action is required.

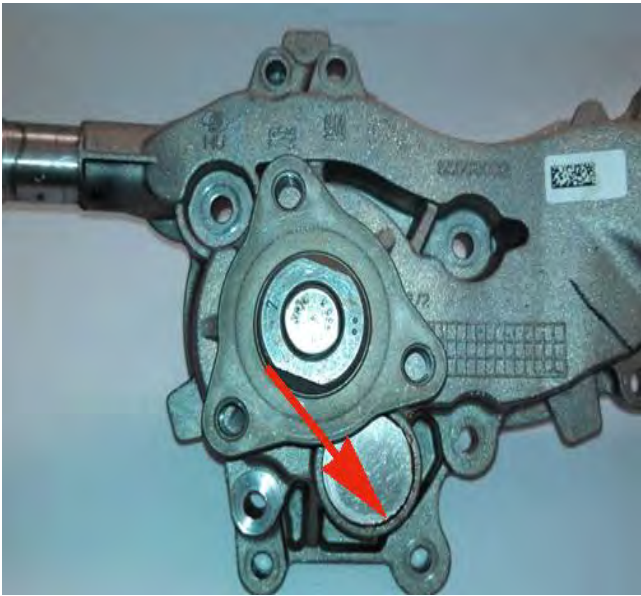
3609233

Only slight coolant staining around the perimeter of the cover plate.

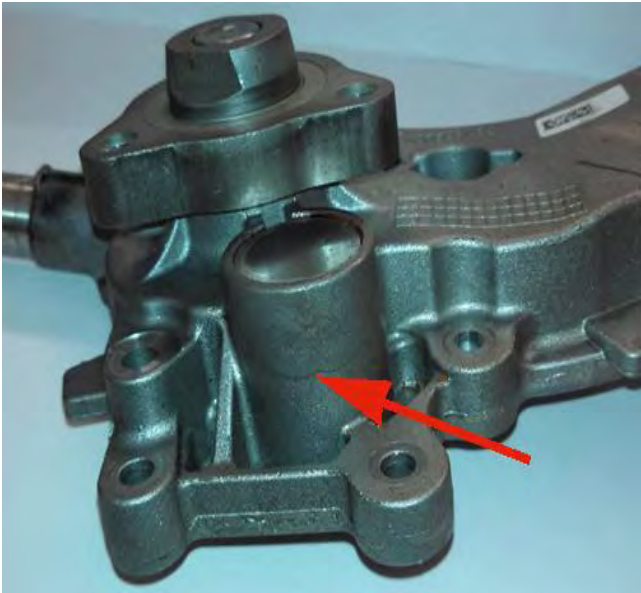
3609237

Only slight coolant staining on the underside of the housing.

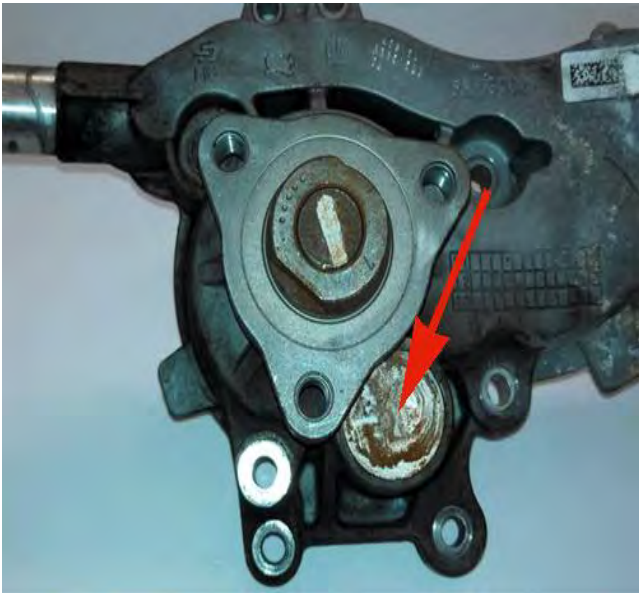
3609253

Excessive Water Pump Coolant Deposits (Replace Pump)

Significant coolant residue on the cover plate.

Remove and replace the water pump if it is obviously leaking coolant or if it has excessive evidence of coolant deposits as described above. Refer to *Water Pump Replacement* in SI for the replacement procedure, which also includes important information about specific bolts that should not be reused as well as all of the related torque specifications.

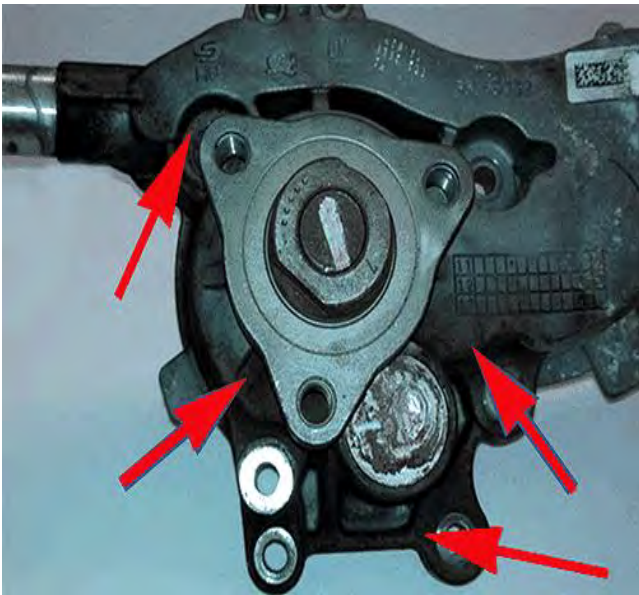
3610640

Evidence of coolant residue on the exterior surfaces of the pump housing.
