Program Bulletin

CUSTOMER SATISFACTION PROGRAM

SUBJECT: Passenger Air Bag Wiring Harness Connector

MODELS: 2009-2010 Chevrolet HHR

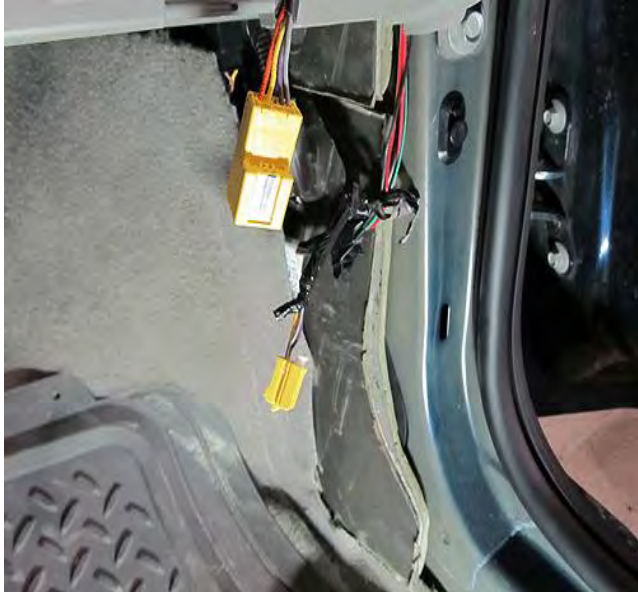
2717043

Important: Note the wire colors on the instrument panel passenger inflatable restraint and body harness. Ensure that the wire colors are matched when installing into the new connector.

6. Cut the wires from the instrument panel harness connector and body harness connector as close to the connector housing as possible to minimize wire length loss. Slide the conduit away on the airbag harness and remove just enough tape on the instrument panel harness to access the wires to install the terminals and seals.
