Service Bulletin

SPECIAL COVERAGE

SUBJECT: Special Coverage Adjustment – Nitrogen Oxide (NOx) Sensor

MODELS: 2010-2011 Chevrolet Express and GMC Savana
Equipped with 6.6L Diesel Engine (RPO LGH)

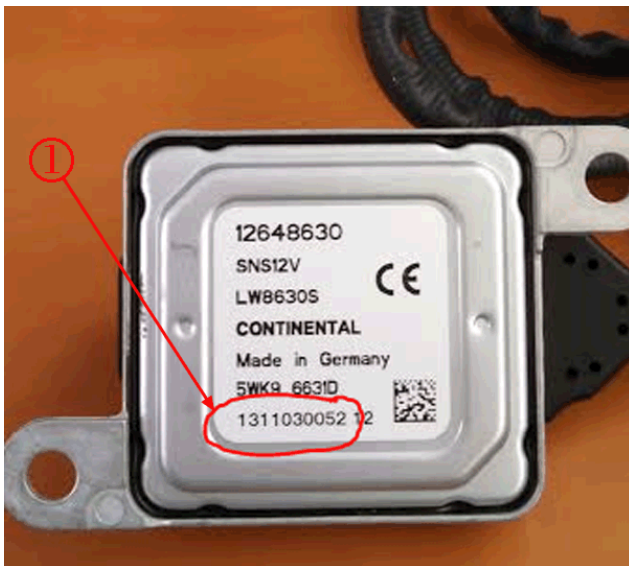
4000071

Note: If diagnosis indicates that only one nitrogen oxide sensor requires replacement, inspect the date code of the other nitrogen oxide sensor to determine if it requires replacement. The date code (1) is located on the back side of the NOx sensor module. The first six digits of the code represent the date code. Refer to the photograph. The example in the photograph has a date code of 131103xxxx, which indicates a November 03, 2013 date code. All NOx sensors with a date code prior to 120914xxxx (September 14, 2012) should be discarded and replaced with a new sensor.
