Service Bulletin

SB-10058750-8543

SUBJECT: Special Coverage Adjustment – Daytime Running Lamp Inoperative

**MODELS: 2007-2012 GMC Acadia
Equipped with High-intensity Discharge Headlamps (RPO TVD)**

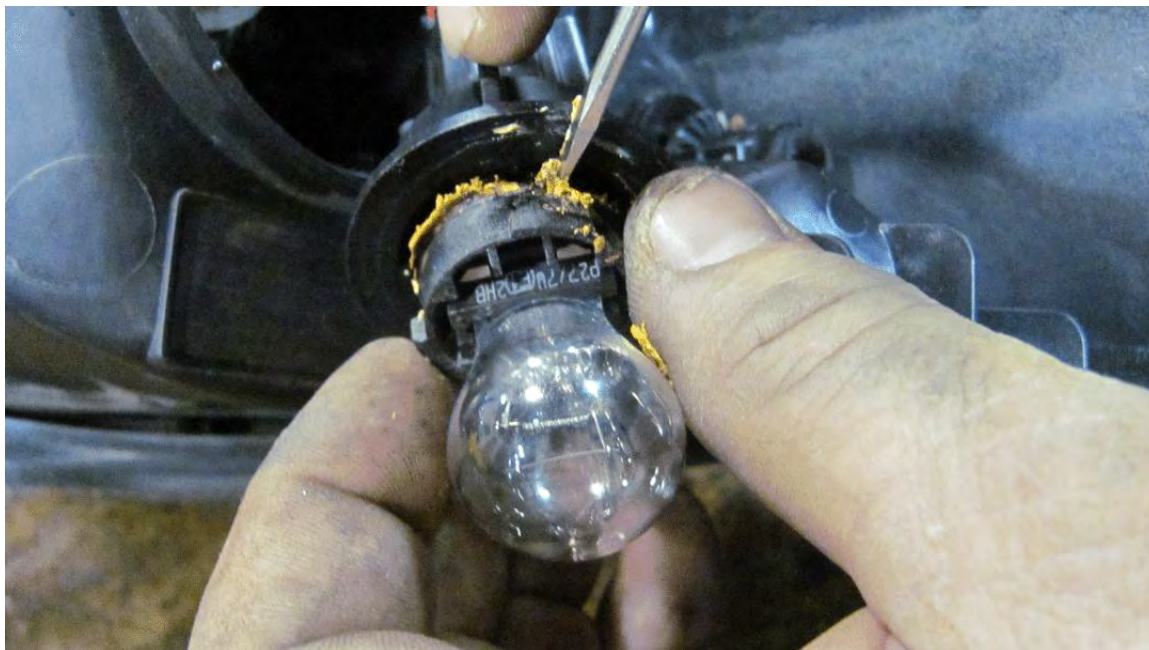
3035227

The “A” portion of the illustration shows the old gasket. The “B” portion of the illustration shows a clean bulb reflector.

- 5. Remove old gasket on the bulb reflector using a shop towel and cleaner.

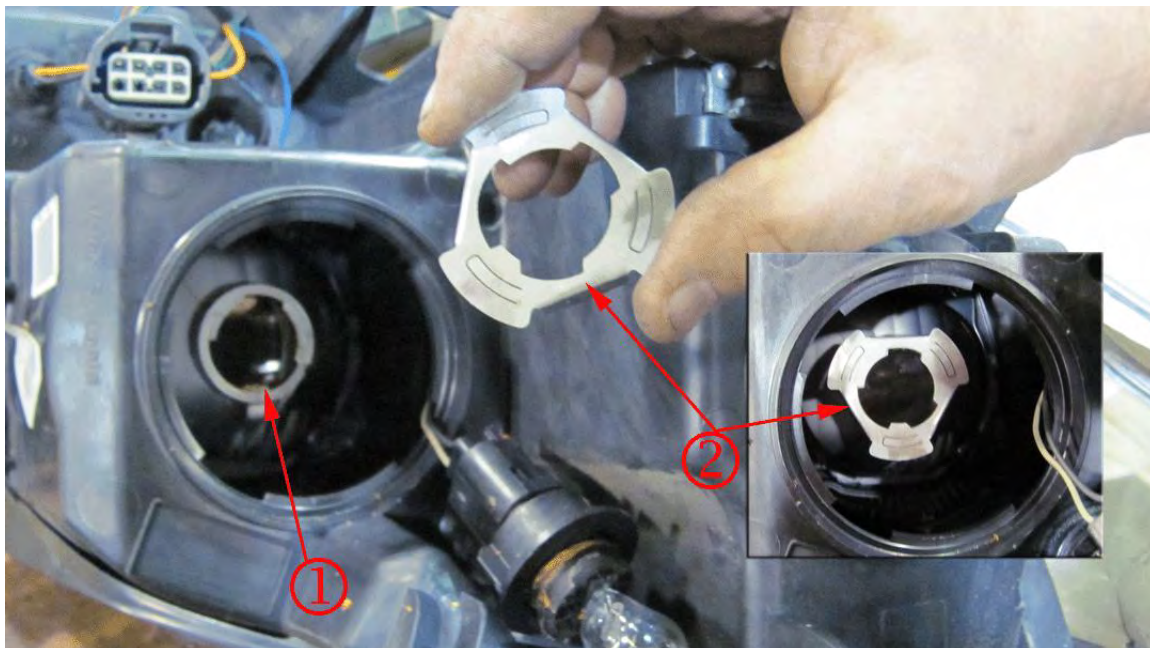
3035516

7. Inspect the reflector lugs (1) for damage, such as cracking, warping, or looseness.
 - If the headlamp reflector lugs (1) are NOT cracked, warped, loose or missing, install the reinforcement plate kit. Refer to 'A' portion of the photograph. The 'A' portion of the photograph shows usable reflectors lug. Do NOT replace the headlamp. Proceed to step 8.
 - If the headlamp reflector lugs (1) are cracked, warped, loose or missing, replace the headlamp. Refer to the 'B' portion of the photograph. The 'B' portion of the photograph shows an unusable reflector lug. The upper lug missing. Proceed to step 13.

Note: Only replace the headlamp if the reflector lugs are damaged or missing.
