Service Bulletin

Bulletin No.: 15356
Date: August 2015

SUBJECT: Special Coverage Adjustment – Loss of Electric Power Steering Assist

**MODELS: 2007-2012 Chevrolet Malibu
2007-2010 Pontiac G6
2007-2010 Saturn AURA
Equipped with Electric Power Steering Assist (EPS)**

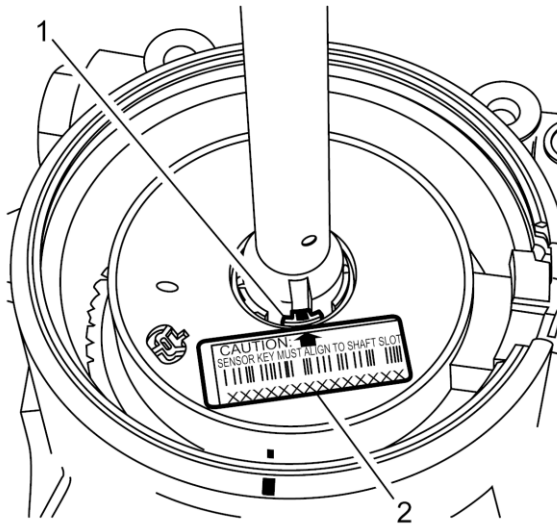
3824308

4. Document the last 9 digits of the NEW steering shaft torque sensor on the vehicle repair order. The serial number is located on the bottom of the caution label (2).
5. If necessary, remove the power steering assist motor. Refer to *Power Steering Assist Motor Replacement* in SI.
6. If necessary, install a new power steering assist motor. Refer to *Power Steering Assist Motor Replacement* in SI.
