Service Bulletin

SPECIAL COVERAGE

SUBJECT: Special Coverage Adjustment – Seatbelt Warning Lights and Chimes with Seatbelt Buckled

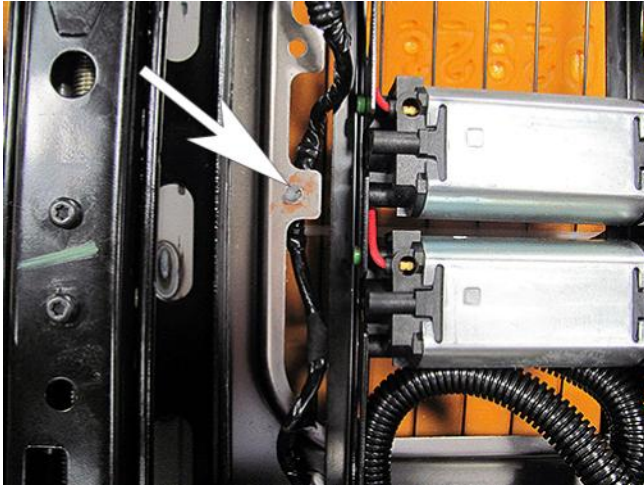
4259163

5. Inspect the seat belt buckle wiring harness for damage.

- If the seat belt buckle wiring harness is not damaged, do not reconnect the harness, proceed to the next numbered step.
- If the seat belt buckle wiring harness is damaged, replace the seat belt buckle assembly. Refer to *Front Seat Belt Buckle Replacement* in SI. Do not connect the new seat belt buckle harness to the seat harness.
