Service Bulletin

SUBJECT: Special Coverage Adjustment – Engine Coolant Leak from the Water Pump

MODELS: 2011-2014 Chevrolet Cruze
2012-2014 Chevrolet Sonic
With 1.4L Engine (RPO LUJ or LUV)

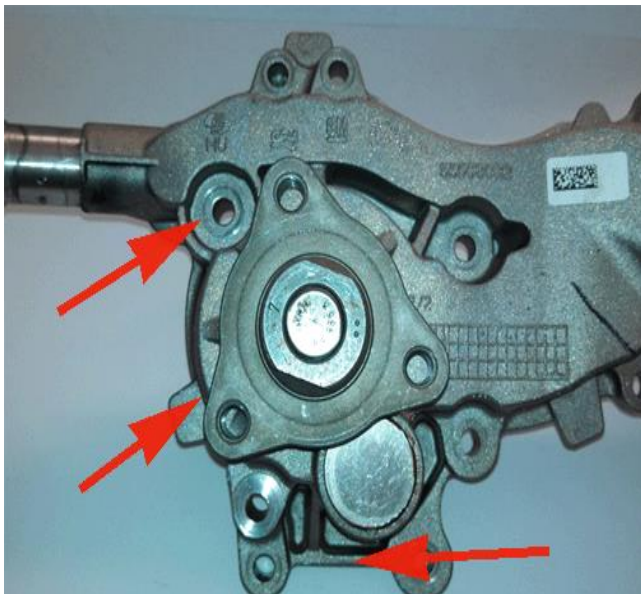
3609232

If the water pump is not obviously leaking and the housing only shows minimal coolant deposits as shown below, do not replace the pump. The water pump is functioning as designed and no further action is required.

No evidence of coolant leakage on the pump body.
