Service Bulletin

SUBJECT: Special Coverage Adjustment – Engine Coolant Leak from the Water Pump

MODELS: 2011-2014 Chevrolet Cruze
2012-2014 Chevrolet Sonic
With 1.4L Engine (RPO LUJ or LUV)

Subject: 14371B – Special Coverage
Engine Coolant Leak from the Water Pump
Revised Warranty Transaction Information Section

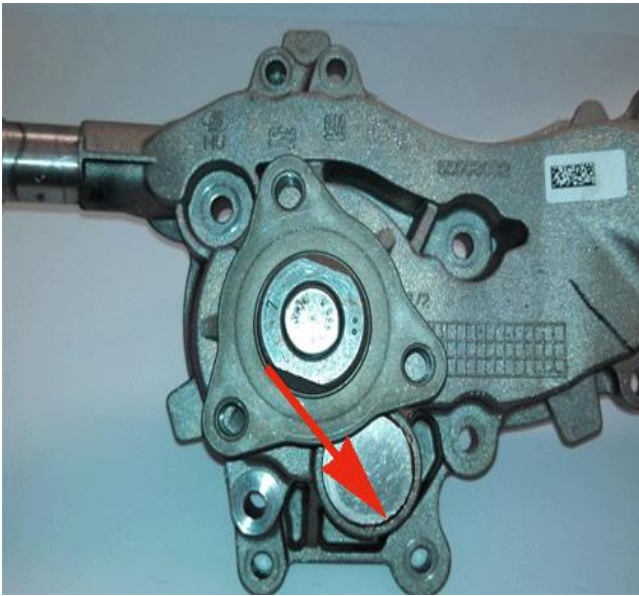
3609233

If the water pump is not obviously leaking and the housing only shows minimal coolant deposits as shown below, do not replace the pump. The water pump is functioning as designed and no further action is required.

Only slight coolant staining around the perimeter of the cover plate.

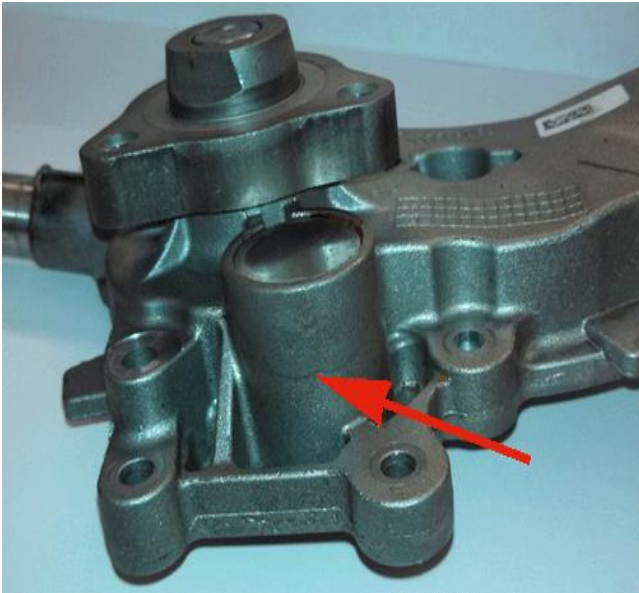
3609237

Only slight coolant staining on the underside of the housing.
