Program Bulletin

CUSTOMER SATISFACTION PROGRAM

SUBJECT: Material Over Sensing and Diagnostic Module Retaining Moisture

MODELS: 2007-2009 Chevrolet Silverado
2007-2009 GMC Sierra

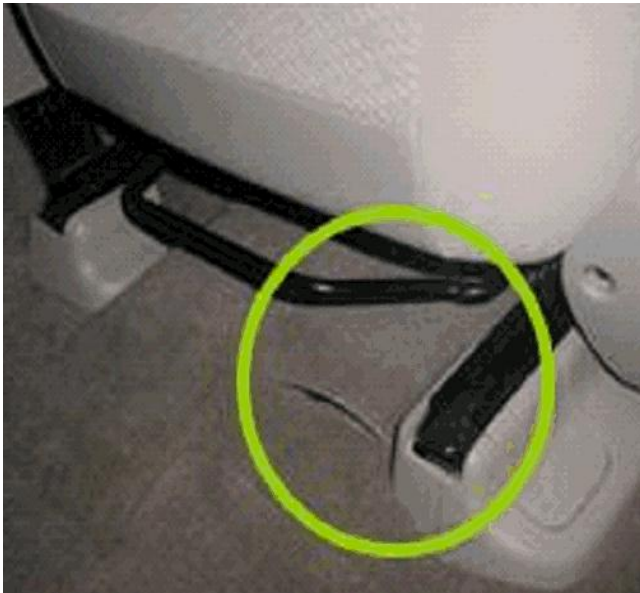
2348430

Note: Driver seat removal is NOT required for crew cab or extended cab vehicles. Certain 2009 regular cab vehicles built after approximately March 1, 2009 with carpet that has a 2-sided cutout over the SDM, however, will require driver seat removal. Refer to *Front Seat Replacement-Bucket* in SI. After the seat removal, proceed to step 4 in the bulletin. Regular cab vehicles with carpet that has a 3-sided cut over the SDM do NOT require seat removal.

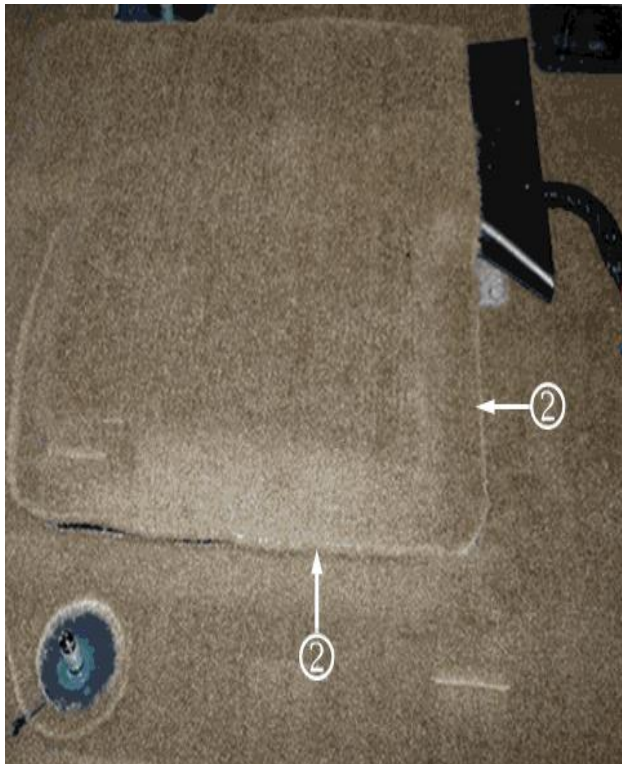
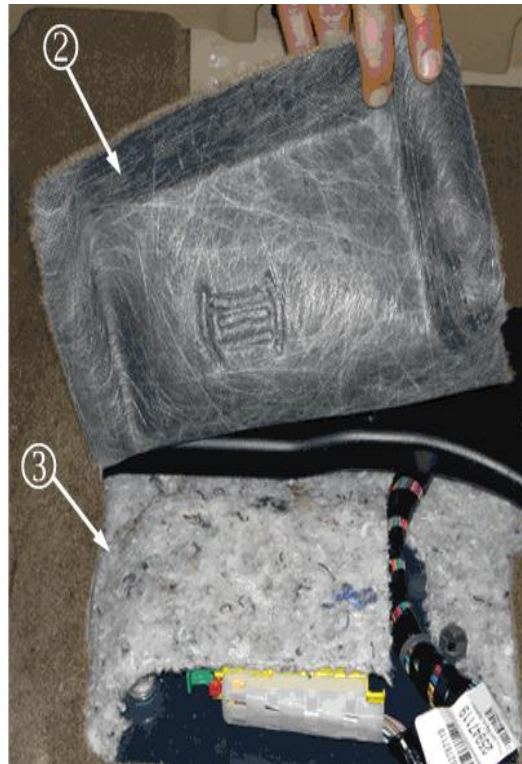
2348426

Carpet and cutout flap (2) shown with the driver's seat removed from the vehicle for illustration purposes only. Seat removal is NOT required to gain access to the acoustical pad (3).

Note: If there is no cutout flap or slit on the vinyl flooring, no further action is required unless the SDM requires replacement. If the vehicle is equipped with vinyl flooring with a slit only, insert your hand into the slit and tear out all of the acoustical pad (3) over the top of the SDM.

4. Lift the cutout flap (2) in the carpet or vinyl to gain access to the acoustical pad (3) that covers the SDM.

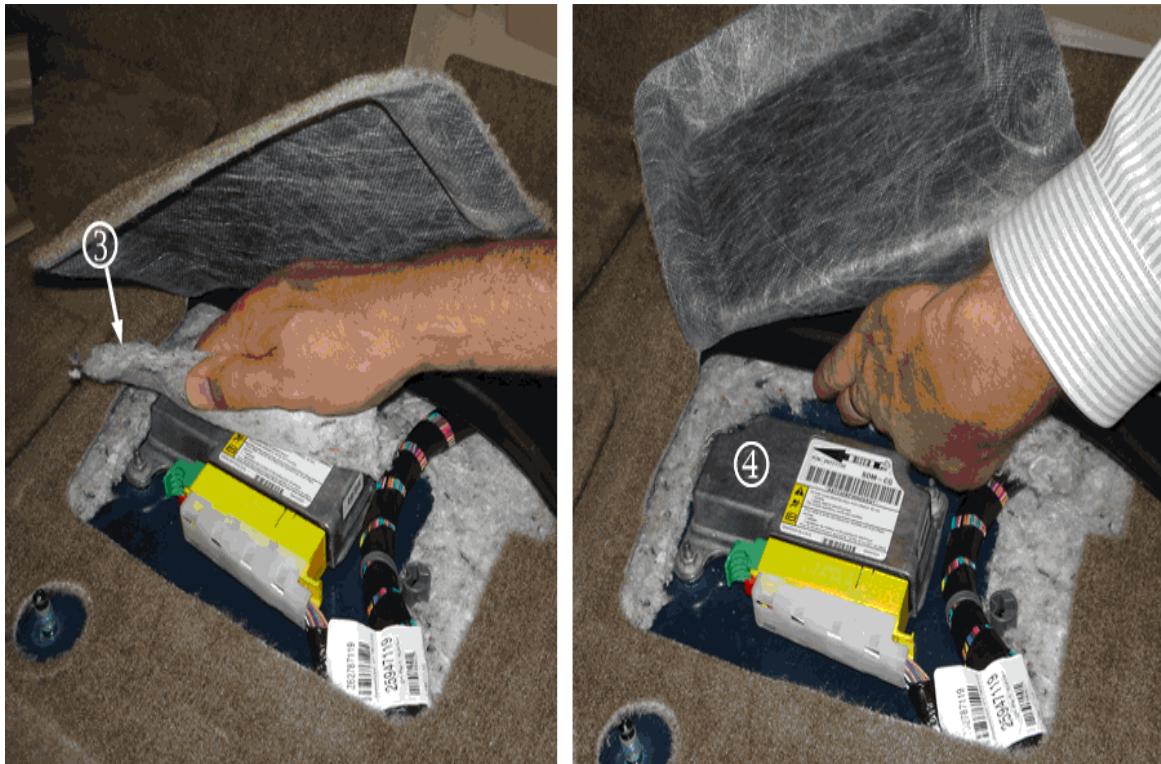
2348426

Seat removed for illustration purposes only

5. Using your hand, tear away and remove the acoustical pad (3) that covers the SDM (4). Ensure that no acoustical pad remains over, or in contact with, the SDM (4).
 - If SDM replacement is NOT required proceed to step 8.
 - If SDM replacement is required, proceed to steps 6-7.

Note: If vehicles equipped with vinyl flooring without a cutout flap or slit require an SDM replacement, remove the front driver seat and lift up the vinyl flooring to gain access to the SDM. Refer to *Front Seat Replacement-Bucket* in SI. Remove the acoustical pad that covers the SDM BEFORE installing the new SDM.

6. Remove the SDM. Refer to *Airbag Sensing and Diagnostic Module Replacement* in SI.
7. Install a new SDM. Refer to *Airbag Sensing and Diagnostic Module Replacement* in SI.
8. Lower the carpet or vinyl cutout flap over SDM (4) and adjust the driver's seat to the customer-desired position.
