# Program Bulletin

## CUSTOMER SATISFACTION PROGRAM

**SUBJECT:** Material Over Sensing and Diagnostic Module Retaining Moisture

**MODELS:** 2007-2009 Chevrolet Silverado  
2007-2009 GMC Sierra  
Currently or Previously Registered in Alaska, Connecticut, Delaware, District of Columbia, Illinois, Indiana, Iowa, Maine, Maryland, Massachusetts, Michigan, Minnesota, Missouri, New Hampshire, New Jersey, New York, Ohio, Pennsylvania, Rhode Island, Vermont, West Virginia, Wisconsin

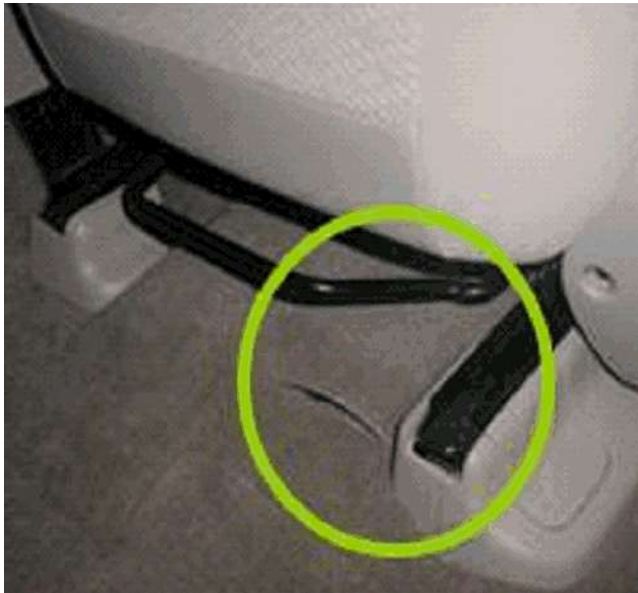
**Note:** Driver seat removal is NOT required for crew cab or extended cab vehicles. Certain 2009 regular cab vehicles built after approximately March 1, 2009 with carpet that has a 2-sided cutout over the SDM, however, will require driver seat removal. Refer to *Front Seat Replacement-Bucket* in SI. After the seat removal, proceed to step 4 in the bulletin. Regular cab vehicles with carpet that has a 3-sided cut over the SDM do NOT require seat removal.

3. Move the driver's seat to the full forward or rearward position.

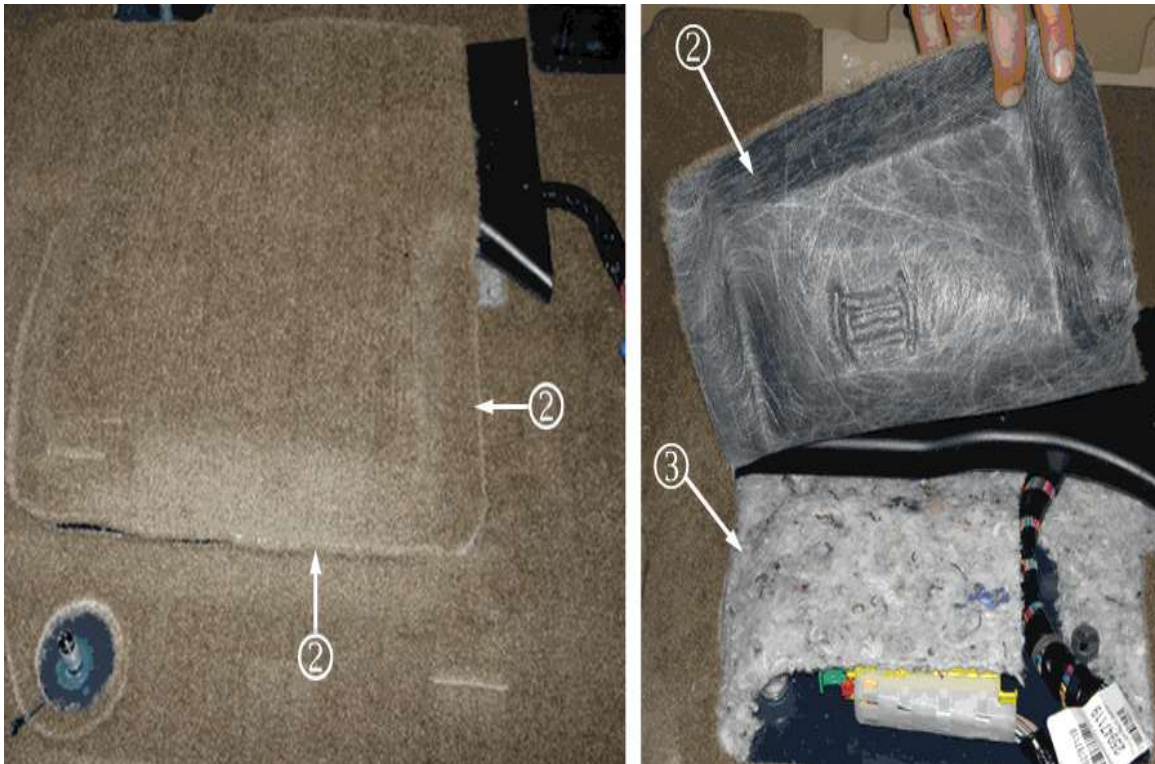
**Note:** Carpet and cutout flap (2) shown with the driver's seat removed from the vehicle for illustration purposes only. Seat removal is NOT required to gain access to the acoustical pad (3).

**Note:** If there is no cutout flap or slit on the vinyl flooring, no further action is required unless the SDM requires replacement. If the vehicle is equipped with vinyl flooring with a slit only, insert your hand into the slit and tear out all of the acoustical pad (3) over the top of the SDM.

4. Lift the cutout flap (2) in the carpet or vinyl to gain access to the acoustical pad (3) that covers the SDM.

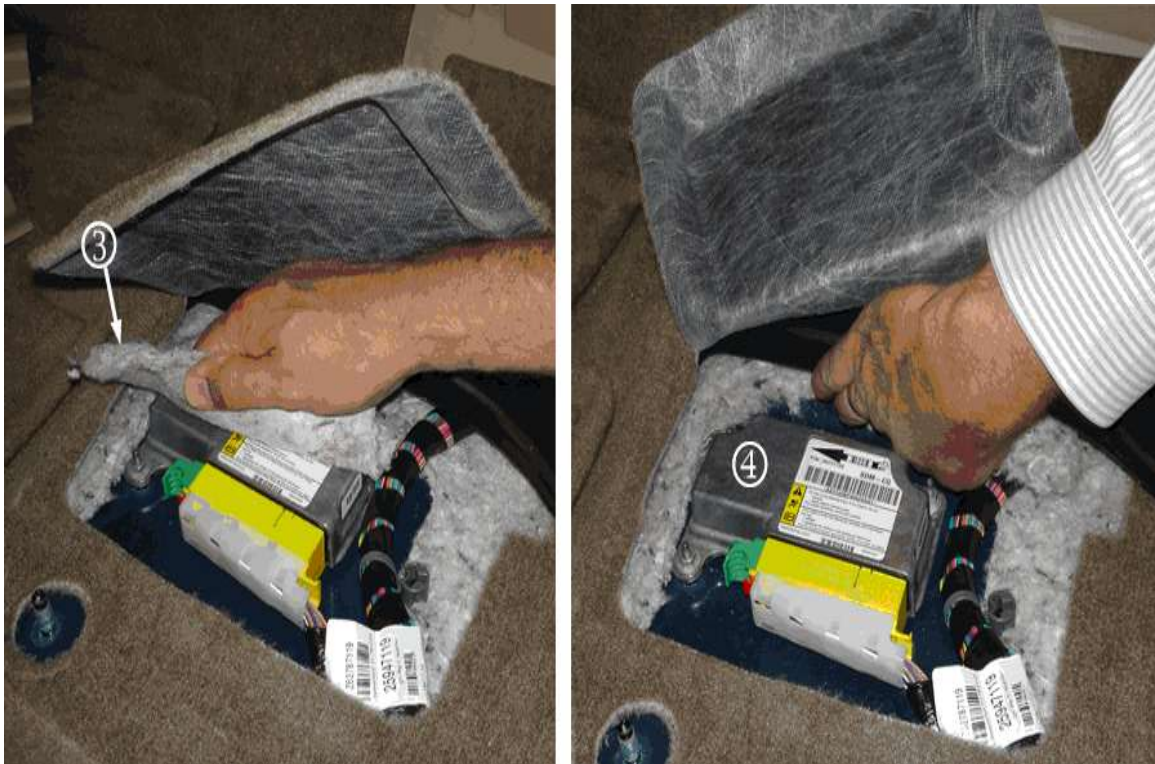
**Note:** Seat removed for illustration purposes only

5. Using your hand, tear away and remove the acoustical pad (3) that covers the SDM (4). Ensure that there is at least a minimum of 13mm (1/2 inch) clearance between the padding to the SDM (4) and no acoustical pad remains over, or in contact with, the SDM (4).
  - If SDM replacement is NOT required proceed to step 8.
  - If SDM replacement is required, proceed to steps 6-7.
