Service Bulletin

SUBJECT: Service Update for Inventory and Customer Vehicles
Transmission Overfill
Expires with Base Warranty

MODELS: 2015-2016 Cadillac Escalade
2016 Cadillac ATS, CTS, Escalade ESV
2015 Chevrolet Silverado LD Ext LTZ
2015 Chevrolet Corvette
2015 GMC Yukon Denali
2016 GMC Yukon XL Denali
Equipped with Transmission M5U or M5N

Subject: 15667 – Service Update Bulletin
Transmission Overfill

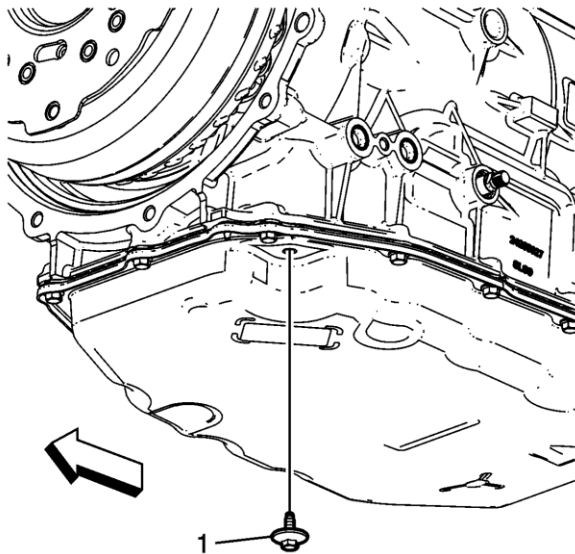
This bulletin provides a service procedure to check and adjust transmission fluid levels on the vehicles listed above. These vehicles may expel extra transmission fluid out of a vent fitting and hose on the top of the transmission.

Caution: The transmission fluid level must be checked when the transmission fluid temperature (TFT) is between 35–45°C (95–113°F). If the TFT is not within this range, operate the vehicle or allow the fluid to cool as required. Setting the fluid level with a TFT outside this range will result in either an under or over-filled transmission. TFT>45°C=under-filled, TFT<35°C=over-filled. An under-filled transmission will cause premature component wear or damage. An over-filled transmission will cause fluid to discharge out the vent tube, fluid foaming, or pump cavitation.

6. Check the transmission fluid level by removing the transmission oil level check plug. Refer to *Transmission Fluid Level and Condition Check* in SI.
7. Allow any fluid to drain until the fluid begins to drip.
8. Reinstall the transmission oil level check plug.
9. Clean off any excess fluid on the transmission fluid pan.
10. Lower the vehicle off of the hoist. Refer to *Lifting and Jacking the Vehicle* in SI.
11. Disconnect the scan tool.
