Service Bulletin

SUBJECT: Service Update for Inventory and Customer Vehicles
Underhood Electrical Center (UEC) Missing Fuses and Relays
Expires with Base Warranty

MODELS: 2015 Chevrolet Silverado
2015 GMC Sierra
Equipped with Accessory Wiring Junction Block (RPO 9L7)

Subject: 15411 – Service Update Bulletin
Underhood Electrical Center (UEC) Missing Fuses and Relays

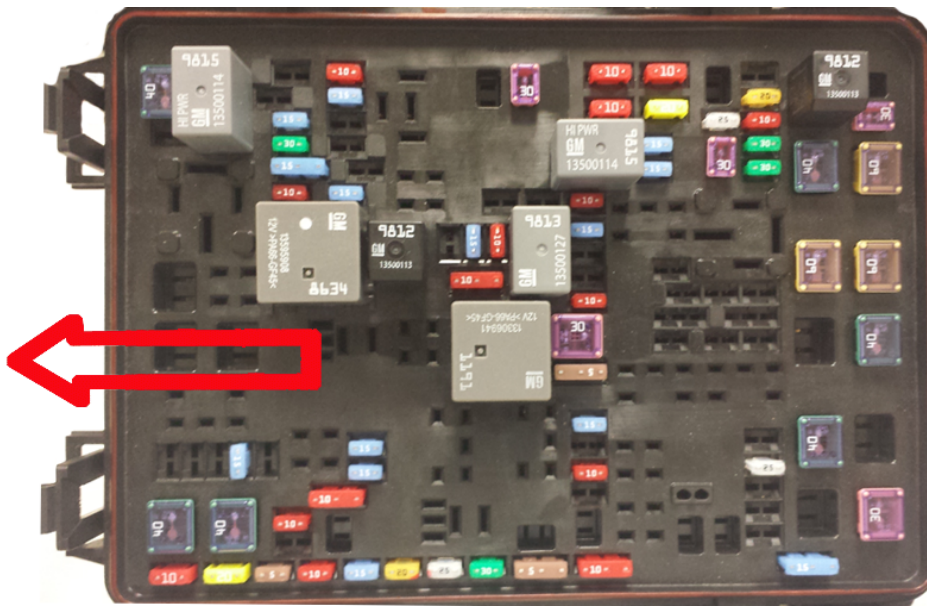
4216857

This bulletin provides a service procedure to install fuses and relays as required in the Underhood Electrical Center (UEC) on **certain** 2015 model year Chevrolet Silverado and GMC Sierra vehicles equipped with an accessory-wiring-junction-block (RPO 9L7). These vehicles may have missing fuses and relays. The customer may notice that the auxiliary switches are inoperative after the function is added to the vehicle.

UEC fuse block *before* fuse and relay installation

2. Locate fuse positions 22 and 27 circled in purple.
3. Install the **two tan** 5A fuses.
4. Locate fuse positions 23, 30, 32, and 37 circled in green.
5. Install the **four green** 30A fuses.
6. Locate relay positions 60, 61, 62, and 65 circled in red.
7. Install the **four gray** HIPWR relays in their correct orientation.
8. Install the UEC cover, and close the hood.

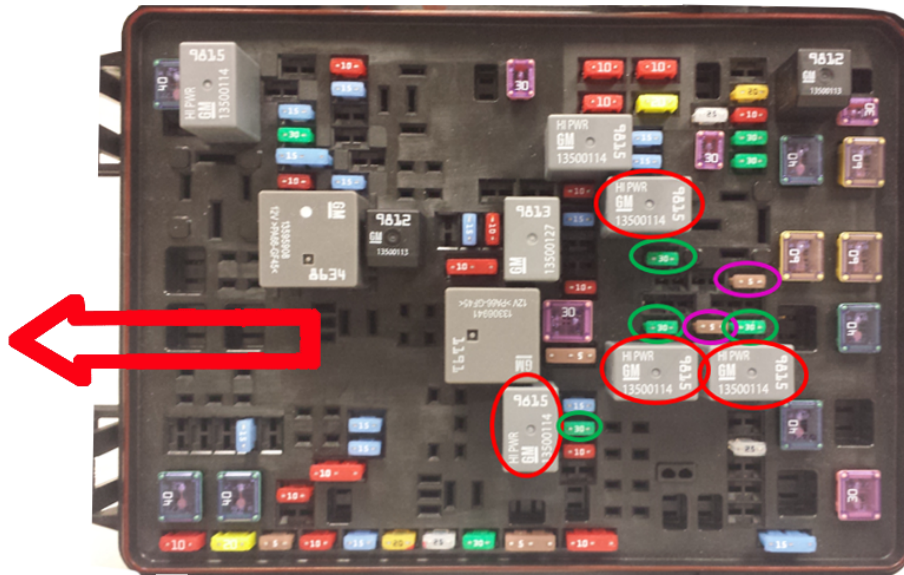
4216858

UEC fuse block *after* fuse and relay installation

Note: Firmly insert components directly from the top, (Do not wiggle).
