SUBJECT: Service Update for Inventory and Customer Vehicles
Instrument Cluster Intermittent Operation and Reset
Expires with Base Warranty

MODELS: 2013 Cadillac ATS, SRX, XTS

Subject: 14687A – Service Update Bulletin
Instrument Cluster Intermittent Operation and Reset
Revised Service Procedure and Warranty Transaction Information
Sections

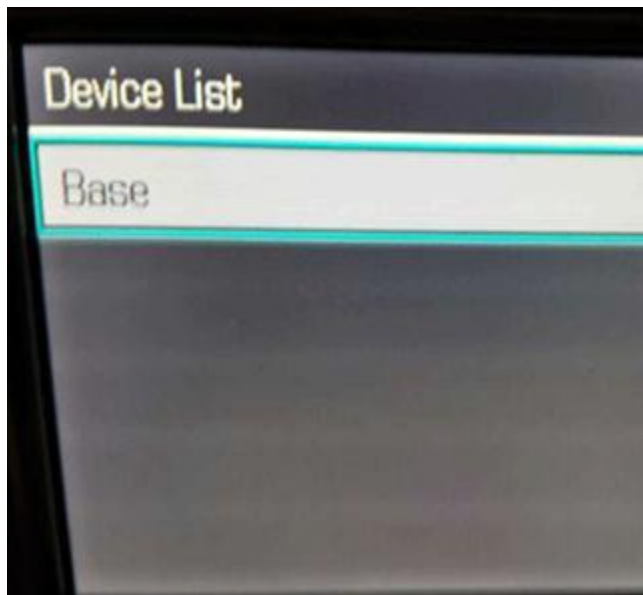
3905983

1. Press the button combination Menu+FAV on the ICS at the same time.

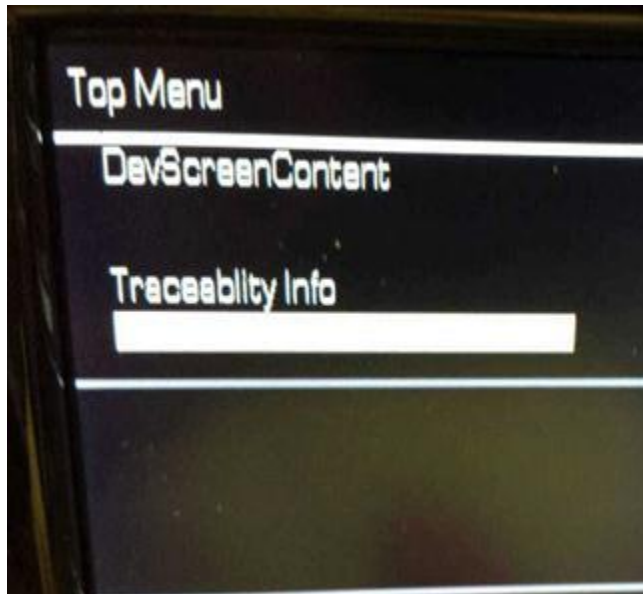
3905986

2. Select Base.

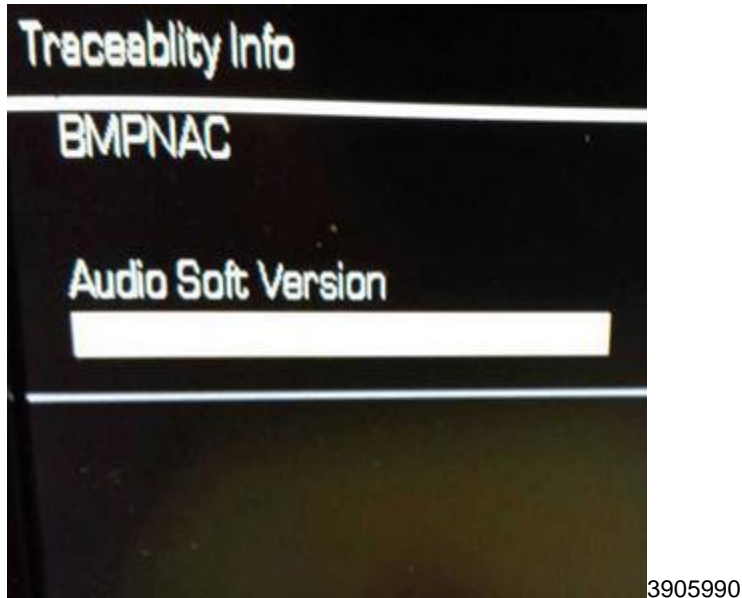
3. Select Traceability Info.
