Bulletin No.: 14636  
Date: April 2015

# Service Bulletin

**SUBJECT:** Special Coverage Adjustment – Reduced Engine Power / Accelerator Pedal Position Sensor

**MODELS:** 2009 Buick Lacrosse  
2009 Buick Allure (Canada)  
2009-2011 Chevrolet Impala

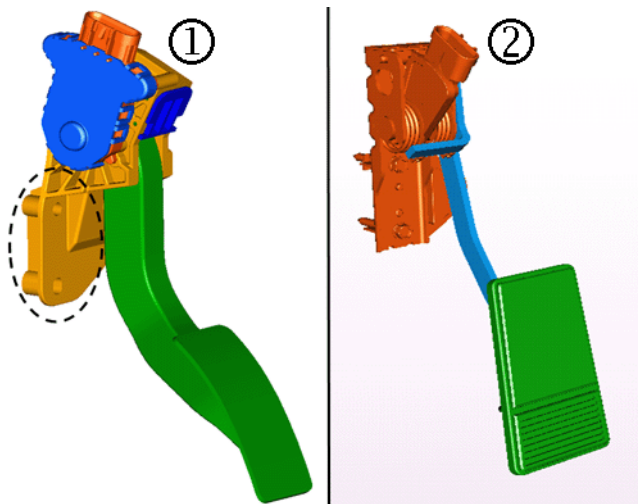
4089974

**Note:** The new replacement pedal (1) has a redesigned mounting bracket, which is shaped differently than the original pedal (2). Its installation requires cutting away a small portion of the insulator/sound dampening material under the instrument panel, to allow the new pedal to attach to the body.
