MODEL  
**2018MY  
Sorento (UMa)**

NUMBER  
**SC159**

DATE  
**December 2017**

**SUBJECT: SIDE CURTAIN AIRBAG REPLACEMENT (SC159)**

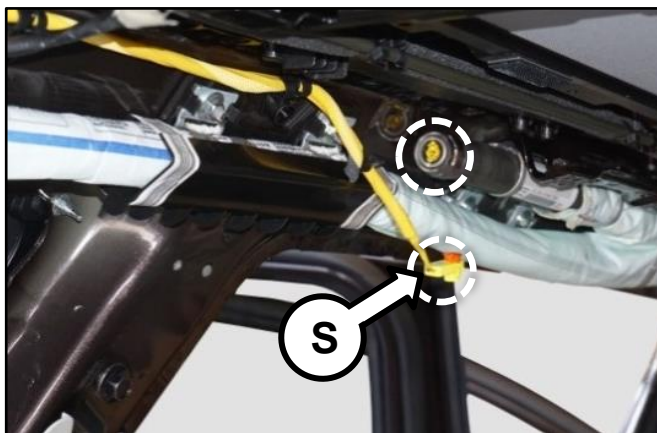
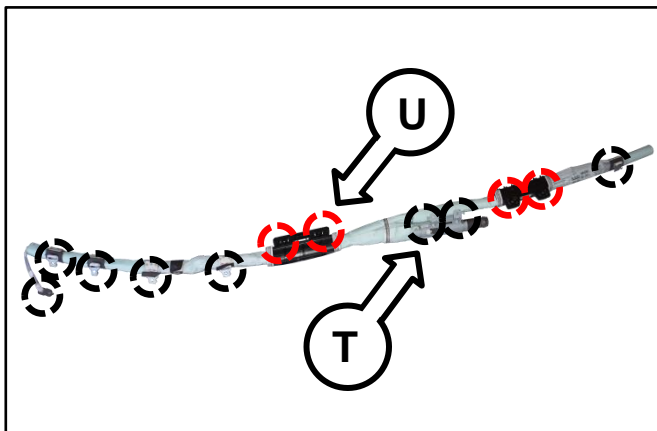
This bulletin provides the procedure to replace both Side Curtain Airbags on certain 2018MY Sorento (UMa) vehicles, produced from September 5, 2017 through November 29, 2017. The inflator in the side curtain airbag is equipped with a top hat diffuser. Some diffusers formed improperly during the manufacturing process. In the event of a crash necessitating deployment of the side curtain airbag, the diffuser may detach and could possibly enter the vehicle occupant compartment, thus increasing the risk of occupant injury.

22. Disconnect the yellow side curtain airbag harness connector (S) from side airbag module. Repeat for the opposite side.
23. Remove the eight (8) retaining bolts (T) and four (4) retaining nuts (U) and remove the side curtain airbag module. Repeat for the opposite side.

**Bolt: 5.8 – 8.7 lb-ft (7.8 – 11.8 N.m, 0.8 – 1.2 kgf.m)**

**Nut: 2.9 – 4.3 lb-ft (3.9 – 5.9 N.m, 0.4 – 0.6 kgf.m)**

24. Install the improved side curtain airbag module then reinstall all removed components in the reverse order of removal.
