PRODUCT CAMPAIGN BULLETIN

<p>APPLICABILITY: 2005-2006 model year Baja 2009-2012 model year Legacy 2009-2012 model year Outback 2009-2012 model year Forester 2006-2012 model year Tribeca 2006-2011 model year Impreza (including WRX and STI) 2012 model year WRX and STI</p>	<p>NUMBERS: TKA-17R TKB-17R TKC-17R</p> <p>DATE: 01/13/17</p> <p>REVISED: 03/21/17</p> <p>NHTSA ID: 17V-014 17V-026 17V-016</p>
<p>SUBJECT: Takata Front Passenger Airbag Inflator Replacement</p>

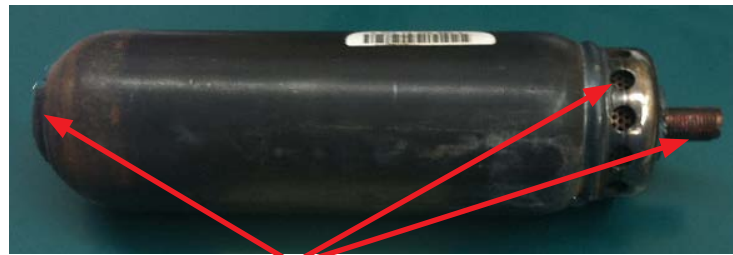
The shape, holes, and copper-colored stud indicate this not a Genuine Subaru inflator.

- **Do not proceed with this repair if your inspection reveals a non-Genuine Subaru air bag module has been installed in the vehicle.** Follow the instructions described in the “Counterfeit Air Bag Information” Dealer Advisory Bulletin.

- Document the presence of the aftermarket or counterfeit device on the repair order and with photos. Report this information immediately on a Quality Monitoring Report (QMR).
