Recall Campaign Bulletin

Campaign No. 2021070027, July, 2022 California Only: 210727

SUBJECT: Model 907 Sprinter, Model Year 2019

Software Update

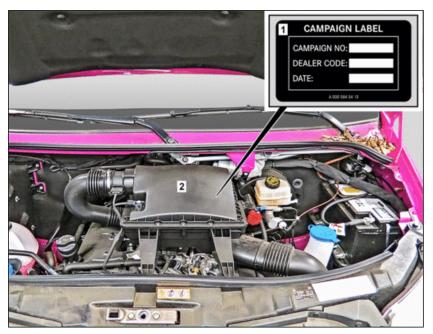
D54.21-A036-76

Shown on model 906 with engine 642

- 1 Campaign label
- 2 Air cleaner housing

attach to air filter housing (2).	of California.	
		Ronding surface must be	
		Bonding surface must be absolutely free of dust and grease.	
		Otherwise, a sufficient degree of	
		adhesion cannot be assured.	
		<u>i</u>	
		To do so, enter 6-digit campaign number, dealer code and date.	
		Cleaner	BR00.45-Z-1025-04A
			D1.00.70 Z 1020-07A
