PRODUCT CAMPAIGN BULLETIN

APPLICABILITY: 2017 MY Outback
SUBJECT: WTE-66 Front Brake Caliper, Wheel Hub and Stabilizer Clamp Attaching Bolt Torque

NUMBERS: WTE-66
DATE: 08/10/16
NHTSA ID: 16V576

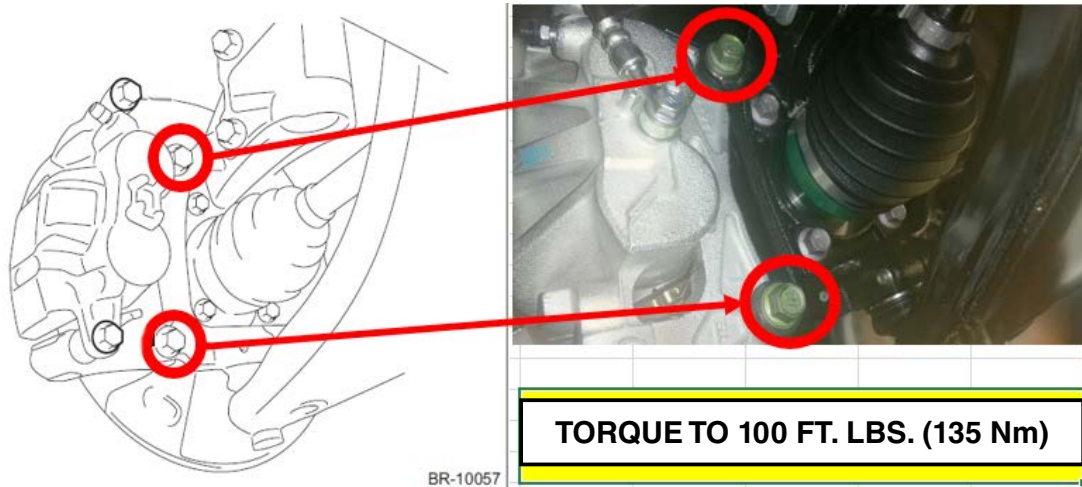
The attaching bolts for the left and right front brake caliper supports, wheel hubs and right stabilizer bar clamp on affected vehicles may not have been sufficiently tightened during production. Should any of the front brake caliper support, wheel hub or stabilizer clamp attaching bolts loosen or detach, the related components would also become loose and could possibly detach. If this were to happen, the vehicle may become unstable and/or no longer provide sufficient braking capability, which could result in a crash.

STEP 2: Using a 17mm socket, verify the torque of the 2- 17mm hex bolts securing the front disc brake caliper support to the axle housing. **Torque each bolt to 100 ft. lbs. (135 Nm).**
