2017 MX-5 RF - CLICKING NOISE FROM ROOF WHILE DRIVING

SI112700

SA NUMBER: SA-038/17

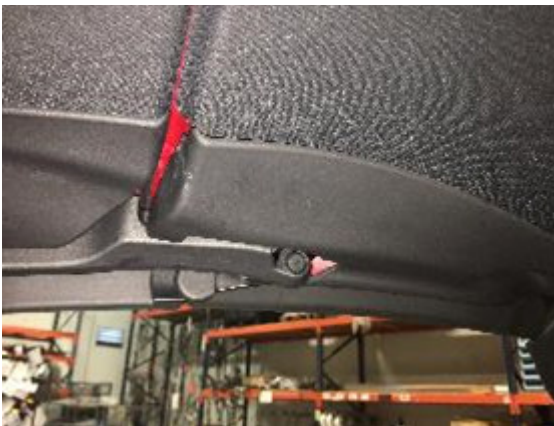
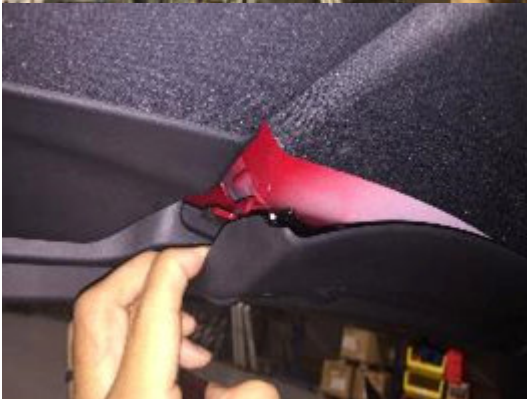
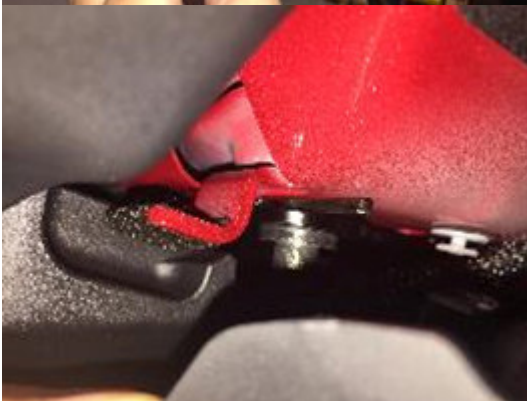
On some 2017 MX-5 RF models, a rattle or click noise may be heard from the roof while driving. This can be caused by contact of the roof stopper related brackets. One of the following dry lubricants can be applied to this area to correct this concern:

1. Access the stopper bracket area behind the roof trim.
