ADVANCED KEYLESS ENTRY SYSTEM MALFUNCTION

SI112712

SA NUMBER: SA-040/17

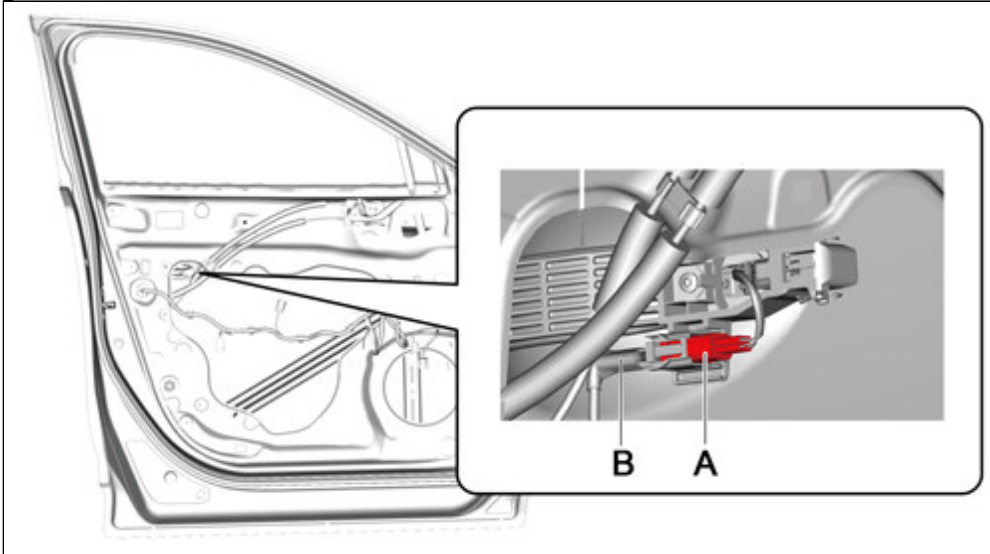
2. Disconnect the outer door handle connector (A) from the door wiring harness short cord connector (B).

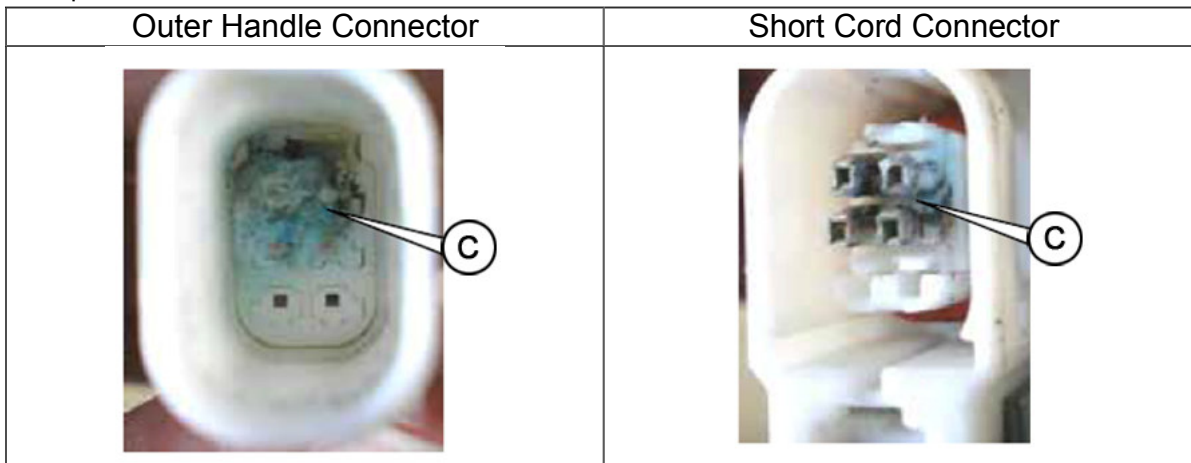
Example

3. Check both front door connector terminals for corrosion (C).

- Corrosion found - Perform steps 4-9.
- No corrosion found - Perform steps 5-9.

4. Replace the outer door handle and the door wiring harness short cord (B) on the affected side.
