Condensation in Semi-Sealed Headlights is Normal

AFFECTED VEHICLES

2015–16 Fit

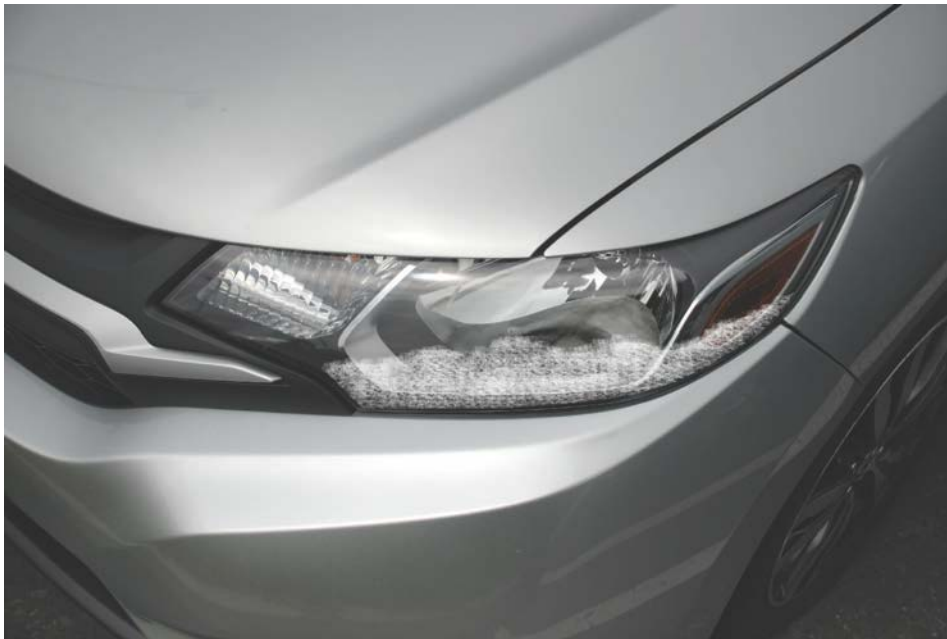
Noticing condensation (fog) inside the headlight assemblies? Well, this is completely normal. These headlight assemblies are a semi-sealed design with ventilation holes that are for preventing heat deformation. However, when it ventilates, it will also include any moisture in the air and condensation occurs inside the headlight.

The headlight becomes foggy when the outside of the headlight is cooler than the inside temperature. Because the headlights vent to the atmosphere, condensation can form inside of them. Due to its structure, the headlights are not defective and should only be replaced if there is standing water in the bottom of the headlight housing, or the water has caused the headlight to lose its function. You may also want to make sure the headlight lenses are not cracked or broken and allowing water to leak inside the housing.

Condensation is a normal occurrence and should dissipate on its own.
