## Tire Pressure Sensor Oxidation Causes Slow Leak

### AFFECTED VEHICLES

2009–14 TL

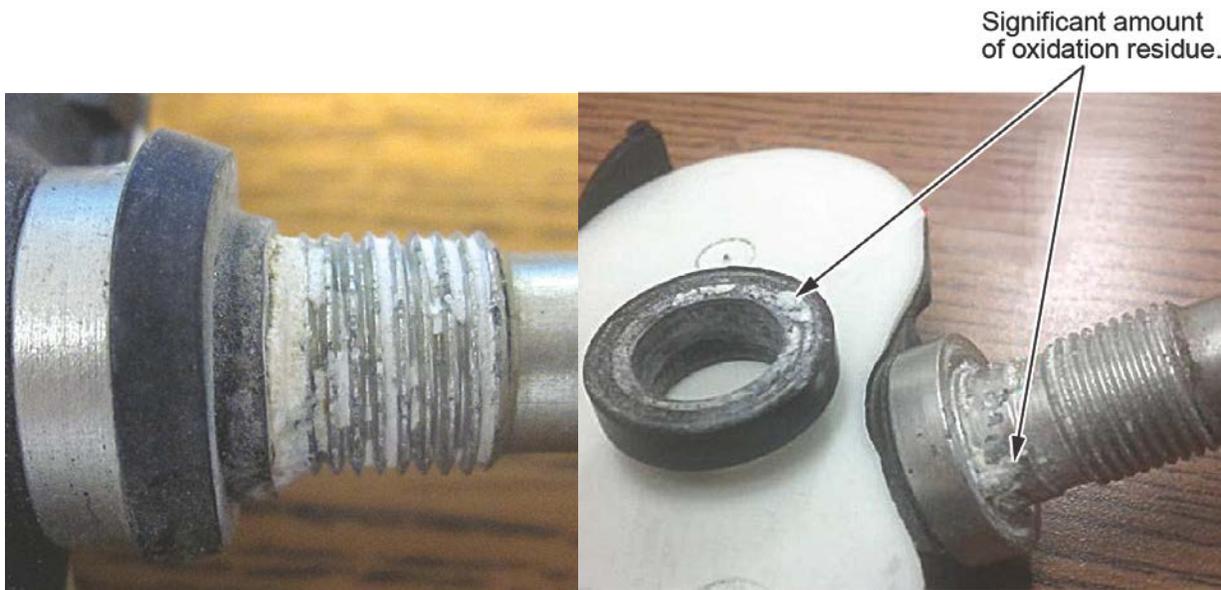
Do you have a slow tire leak, but there are no signs of side wall damage or anything stuck in the tread? While you're checking for leaks, check the valve stem; it could have oxidation buildup from road salt. This buildup can cause a poor seal, resulting in a slow leak.

Apply soapy water to the valve stem. If you see any bubbles coming from it, follow the procedure below. If you don't see any, then look for other possible causes.

1. Remove the tire from the wheel and inspect the valve stem for oxidation. The oxidation looks like a white, powdery residue.
  - If you see any oxidation, go to step 2.
  - If you don't see any oxidation, the tire pressure sensor may have micro cracks or some other problem causing an air leakage. Replace the sensor.
2. Remove the valve stem nut and washer, then remove the sensor from the wheel.
3. Remove and discard the grommet, then remove any oxidation from the stem.
4. Reinstall the sensor with a new grommet (P/N 42756-SHJ-A52), then torque the valve stem nut to **3 lb-ft (4 N·m)**.

**NOTE:** Don't overtorque the valve stem nut. If you do, you'll crush the grommet, forming a gap or space. This will let road salt collect and form a leak path once again.
