HYUNDAI Technical Service Bulletin

Group	ENGINE MECHANICAL
Number	01-20-002-1
Date	OCTOBER, 2001
Model	2001 2.4L SONATA/SANTA FE

**2001 SONATA / SANTA FE 2.4L ENGINE
RUNS ROUGH, IDLES ROUGH, DTC P0335**

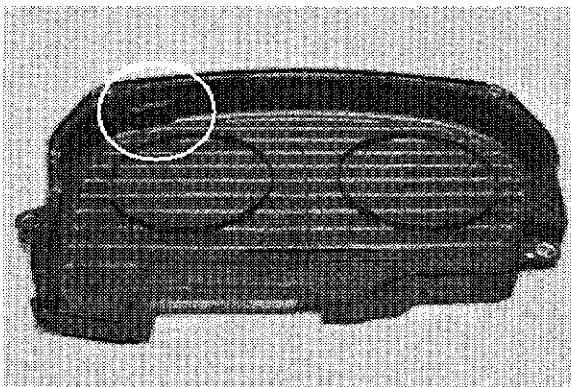
Location of the timing belt guide.

A new timing belt cover P/N 21360-38214-D that incorporates a timing belt guide has been installed on vehicles produced since January 30, 2001.

Vehicles that experience the condition described above should be updated with the new timing belt cover

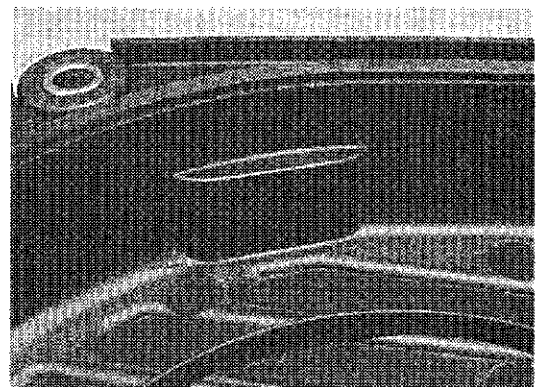
Close up of the guide.

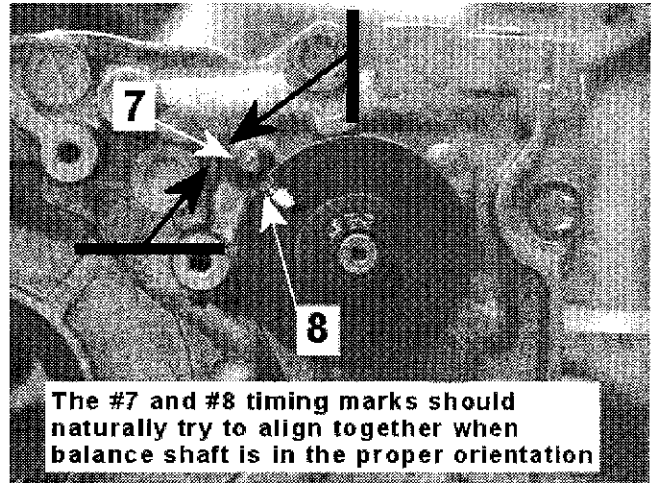
Timing marks #7 and #8 will naturally align when the balance shaft is in the proper orientation.

8. Set the oil pump sprocket so that timing marks #7 and #8 are aligned. Quickly rotate the sprocket back and forth, between the 9 and 12 o'clock position "feeling" for a "centering feel" when the timing marks meet. If the sprocket timing mark feels like it wants to move away from the other mark, rotate the sprocket one complete revolution and try it again.

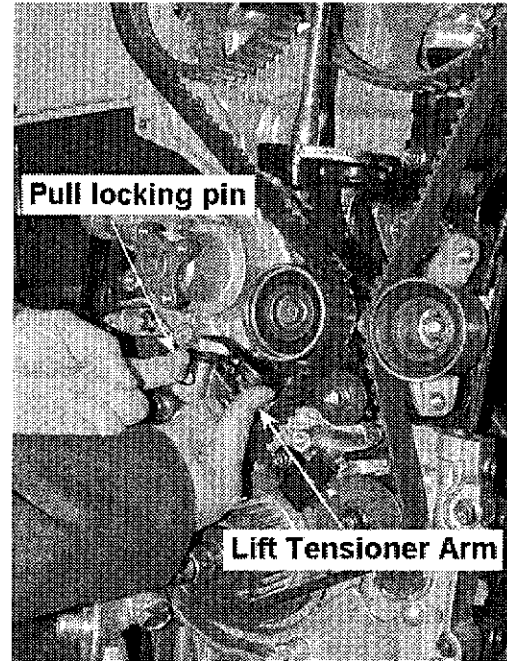
NOTE: Due to the difference in ratio between the crank sprocket and the oil pump sprocket, the oil pump sprocket will appear out of time after turning the crankshaft 2 revolutions (provided the sprocket was set properly in steps 8 and 9). The oil pump sprocket will come into alignment on the 6th revolution (1 : 1.5 ratio; crank to oil pump).

11. Apply hand pressure to the tensioner pulley to take up any slack, and remove the lock pin from the tensioner. Remove cam sprocket holder.
12. Rotate the crankshaft clockwise (by hand) 2 complete revolutions and set to TDC. If the TDC mark was passed, then rotate the crankshaft another two complete revolutions. The crankshaft must only be turned clockwise for proper tension and orientation of the timing marks.
13. Inspect the timing marks of the cam sprockets for proper timing.
