**CREAKING NOISE FROM FRONT LOWER CONTROL ARM BUSHINGS**

**Bulletin No:** 02-001/15

**Last Issued:** 01/14/2015

2013-2015 Mazda3

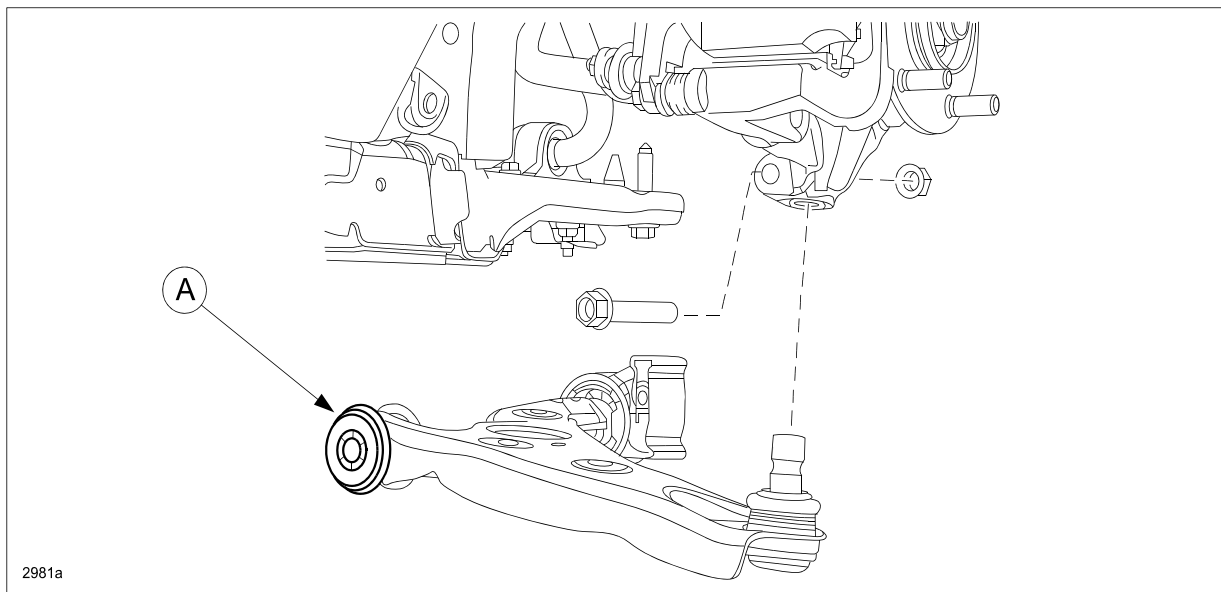
Some vehicles may exhibit a creaking noise from under the front of the vehicle when driving over bumps. The noise occurs at approx. 12 - 25 mph (20 - 40 Km/h) when the road surface is wet or after a car wash. The noise becomes more noticeable when driving over higher bumps.

The creaking noise is caused when the front lower control arm bushing(s) (A) become wet.

1. If possible, verify the customer concern when driving over bumps under wet conditions.
2. Replace front lower control arm bushing with new service part according to Steps 3 - 8.
3. Remove the front lower control arm according to the on-line instructions on MS3 or the Workshop Manual (section 02-13 FRONT LOWER ARM REMOVAL/INSTALLATION).
4. Remove the front lower arm bushing using SSTs 49 G030 797 and 49 B025 004.
5. Place the SSTs on the front lower control arm as shown below, then press out the bushing.

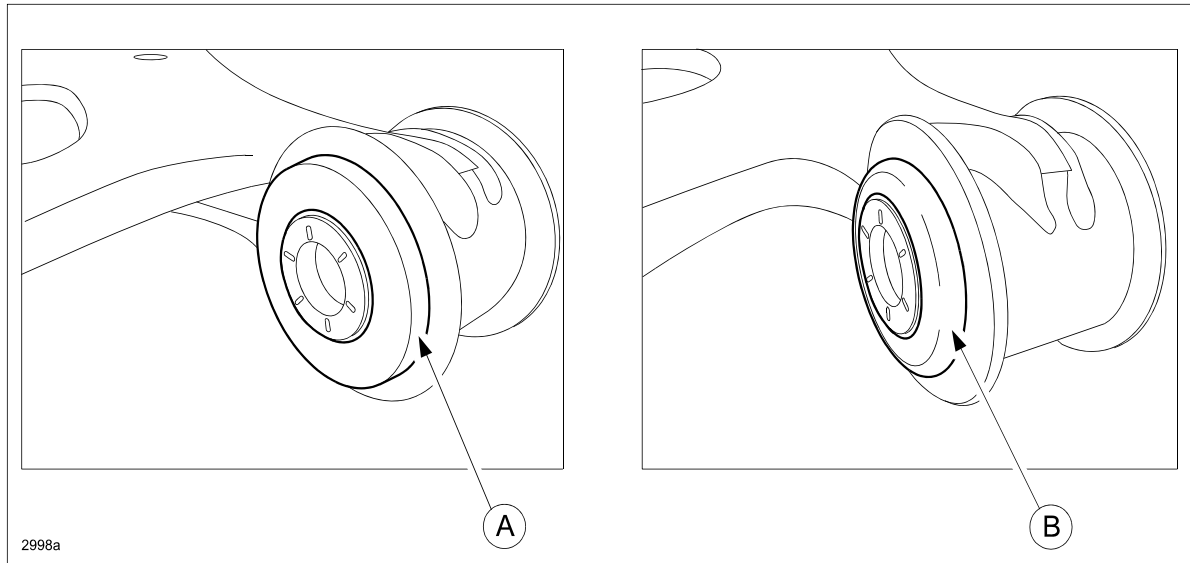
**CAUTION:** Make sure the bushing has been properly inserted by verifying that the bushing tab **IS FULLY EXPANDED**, as shown in the illustration to the left (A). The illustration to the right (B) shows an example of a bushing tab that **IS NOT FULLY EXPANDED**.
