NUMBER: 03-001-15 REV. A

Rear Half Shaft Vibration

2015	(LX)	Chrysler 300
2015	(LD)	Dodge Charger
2015	(LA)	Dodge Challenger

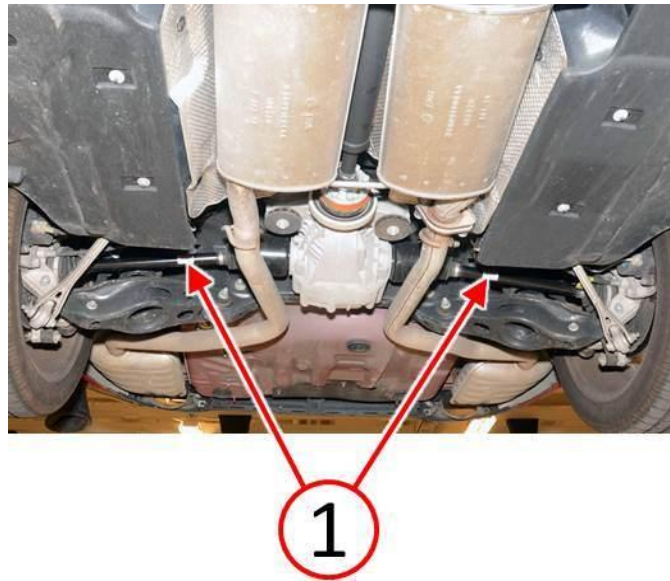
Fig. 1 Identification Label Location

1. **Raise the vehicle and locate the axle shaft identification labels (1) (Fig. 1). Refer to the detailed service procedures available in DealerCONNECT> TechCONNECT under: Service Info> 04 - Vehicle Quick Reference> Hoisting> Standard Procedure.**

1 - Identification Labels

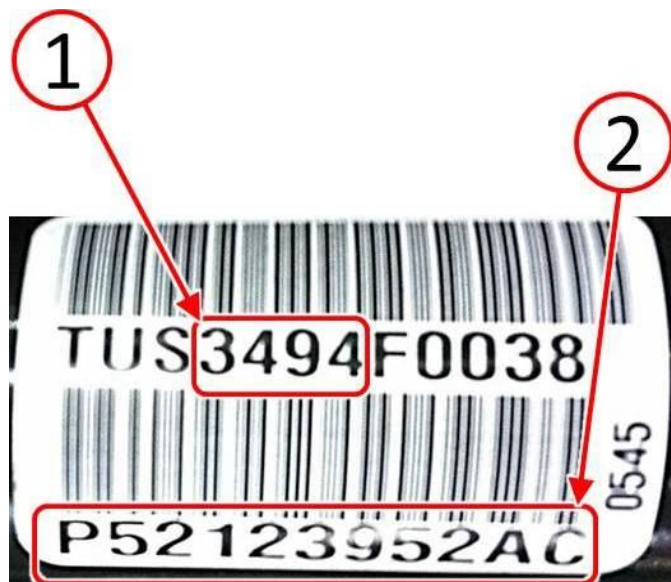
Fig. 2 Identification Label Information

2. ****Inspect the affected date code range (1) on both axle shaft identification labels (Fig. 2).****

1 - Date Code Range

3. ****Is the affected date code range any number between 3094 through 3384?**

- a. YES>>> Continue with the Repair Procedure [Step #4](#).
 - b. NO>>> This bulletin has been completed, use LOP (03-20-03-92) to close the active RRT. If the customer described the symptom/condition listed above, normal diagnosis should be performed.**
4. Replace both rear half shafts. Refer to the detailed service procedures available in DealerCONNECT> TechCONNECT under: Service Info> 02 - Differential and Driveline> Half Shaft> Removal/Installation.
