| Subject: WHINING NOISE FROM AUTOMATIC TRANSAXLE | Bulletin No: 05-005/15 |
| | Last Issued: 04/08/2015 |

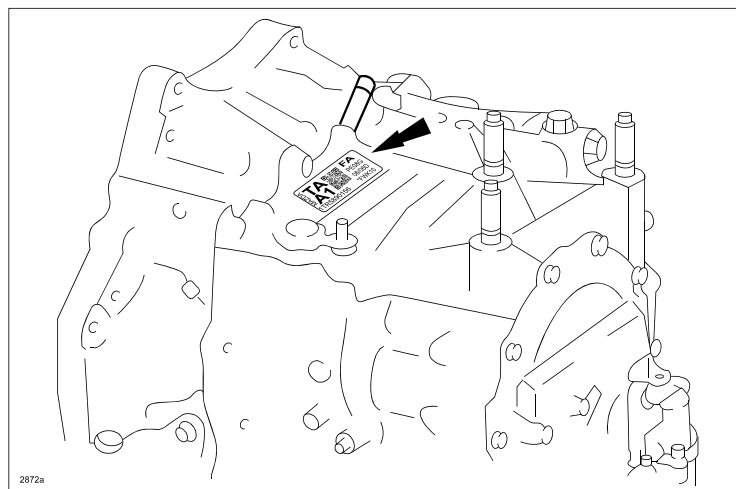
This is caused by a damaged bearing in the transaxle due to improper configuration of the transaxle case. A modification has now been implemented on automatic transaxles with the serial number 3TR1111680 and higher or 3TD1104906 and higher. The serial number can be found on top of the transaxle case near the manual shaft lever.

1. Verify customer concern.
2. Replace the 6AT assembly with a new one according to MS3 online instructions or Workshop Manual section 05-17.
3. Verify repair.
