SERVICE BULLETIN

APPLICABILITY: 2010-14MY Legacy and Outback Models
SUBJECT: Design Change to Retaining Clip for Front ABS Wheel Speed Sensor

NUMBER: 06-49-15R
DATE: 05/29/15
REVISED: 02/08/16

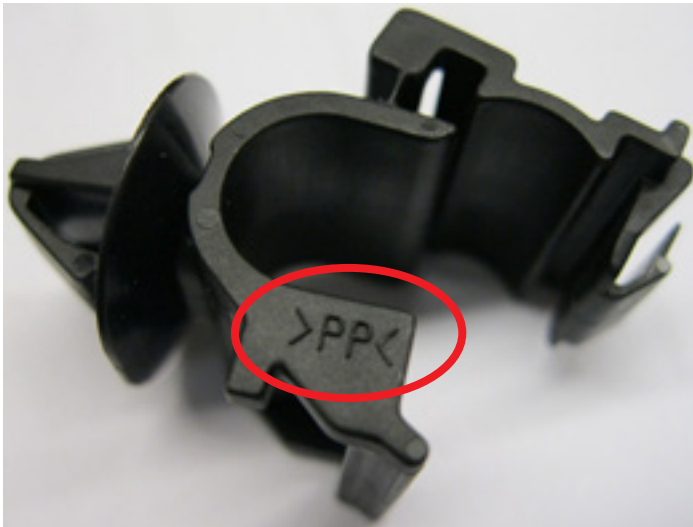
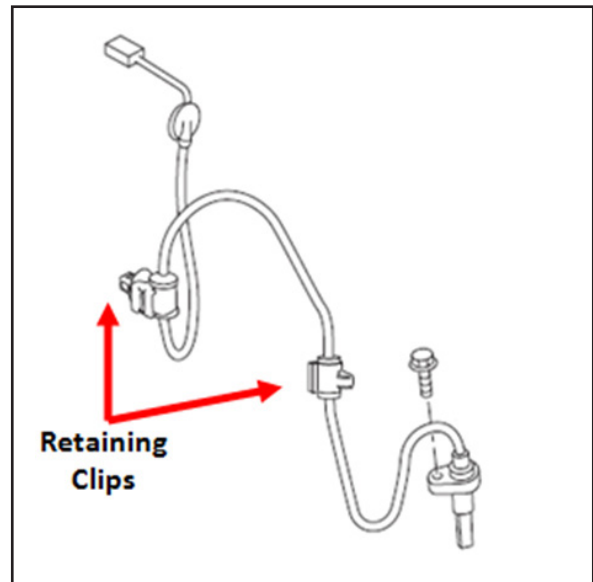
In response to isolated reports of cracked or broken ABS wheel speed sensor harness retaining clips caused by reaction with acids used in some wheel cleaners, the clip material has been changed to polypropylene (PPO).

The new retaining clips can be identified by the molded in >PP< as shown in the photo below. There are 2 clips on each sensor harness.

IMPORTANT: In the event a cracked or broken sensor harness retaining clip is identified, **all 4** of the clips (2 per side) **MUST** be replaced.

CAREFULLY remove the retaining clips from the sensor harness and always install the replacement clips back in the same position as the originals.
