Subject: BLOWER MOTOR SPEEDS 1 - 3 ARE INOPERATIVE	Bulletin No: 07-001/15
	Last Issued: 01/14/2015

2013-2015 CX-5 vehicles equipped with a manual air conditioning system OR without air conditioning.

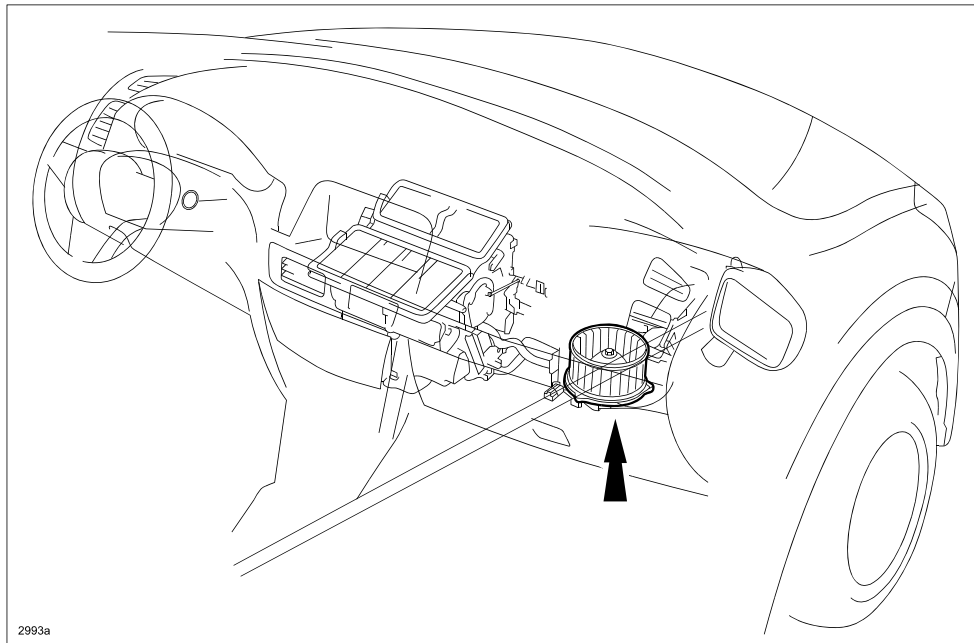
Some vehicles (only equipped with manual A/C or without A/C) may exhibit a blower motor that only operates in the highest speed (4th) and does not operate at speeds 1 - 3. This concern occurs mostly in colder regions and may be caused by a blown resistor fuse.

To eliminate this concern, a special service part blower motor has been established.

1. Verify the customer concern.
2. Replace the blower motor and resistor with a special service part according to the instructions on MS3 online or the Workshop Manual (section 07-40 BLOWER MOTOR REMOVAL/INSTALLATION [MANUAL AIR CONDITIONING SYSTEM]).
3. Verify repair.
