SERVICE INFORMATION BULLETIN

NUMBER: 07-116-16R

SUBJECT: Supplemental Service Procedure Information to be Used in Conjunction with Campaigns WQP-51, WQR-53R and TKA, B, C-16R

DATE: 11/11/16

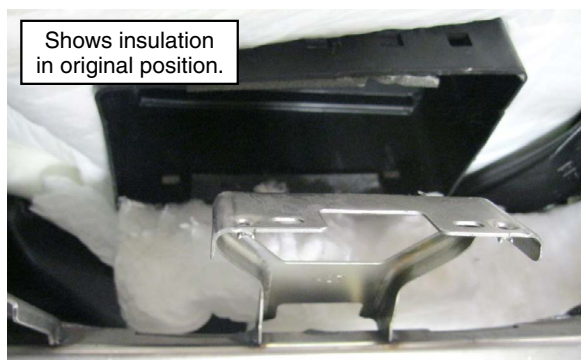
Shows insulation in original position.

TIP: As shown in the photo below, there is a substantial amount of white poly-fill / insulation material around the airbag module location. Before reinstalling the module, **CAREFULLY** tuck the material up into the gap between the air supply duct and underside of the IP to get it out of the way of the “front” retaining claws. Once the module is locked back into position, reach up behind (ahead of) it, **CAREFULLY** pull the insulation back out and put it back into its original position.

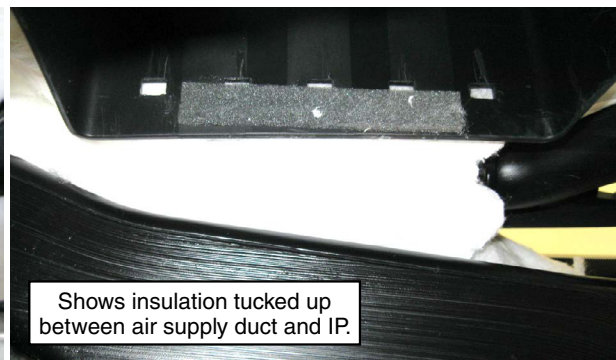
Shows insulation tucked up between air supply duct and IP.

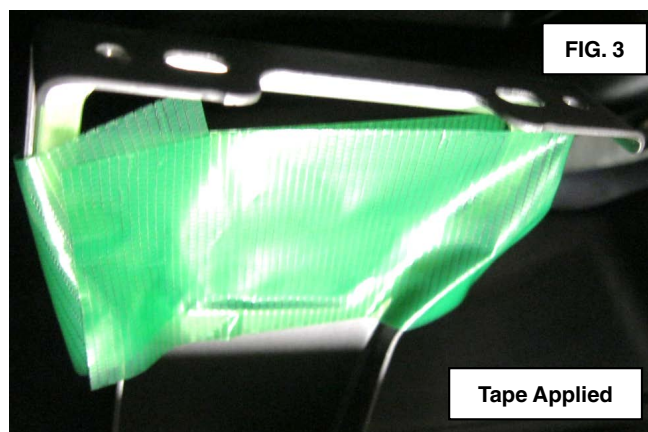
- On these models, there is an additional support brace for the IP attached to the steering column support bar (Fig. 1 below). The bracket has an opening in it which the mounting bracket for the airbag module fits through easily. The airbag module cannot be removed if its mounting bracket becomes caught in this brace (Fig. 2). **BEFORE** attempting to remove the airbag module, apply a piece of duct tape (or equivalent) to the brace (Fig. 3) to prevent this.
