**SERVICE BULLETIN**

**APPLICABILITY:** 2000MY and Later Legacy/Outback  
 2.5L SOHC Vehicles  
 1999MY and Later Impreza and  
 Forester 2.5L SOHC Vehicles

**NUMBER:** 07-60-07R  
**DATE:** 04/25/07

**SUBJECT:** Ignition Coil and High Tension Cables

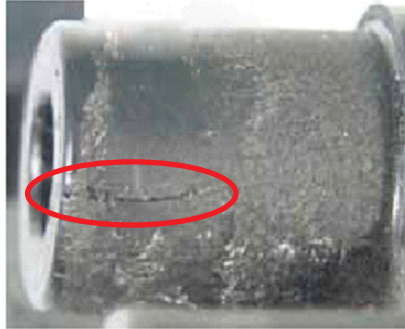
**FIGURE 1**

Check the tower portion of the ignition coil for carbon tracks (leakage). If leakage is more than 5mm long, the ignition coil and high tension cables should be replaced (see Figure 1).

Example of leakage on ignition coil tower.

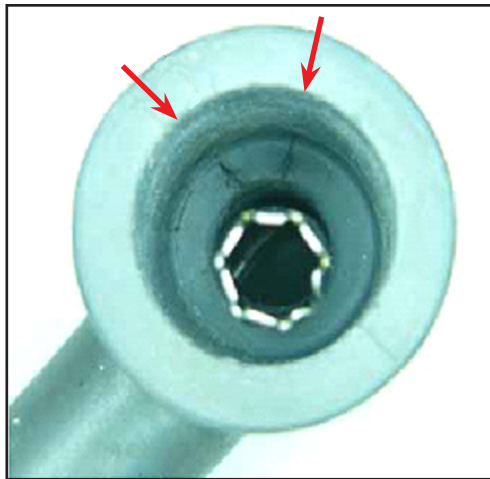
**FIGURE 2**

Check the high tension cables for carbon tracks (leakage). If leakage is evident, the high tension cables should be replaced and the ignition coil cleaned (see **Figure 2** and refer to **Step 3**).

Leakage on cable.

- If there is any evidence of carbon, clean the surface of the ignition coil using a clean, soft rag dampened with water.
- Permit the ignition coil to dry.
- Clean the same area of the ignition coil using a clean soft rag dampened with Isopropyl alcohol.
- Permit the ignition coil to dry.

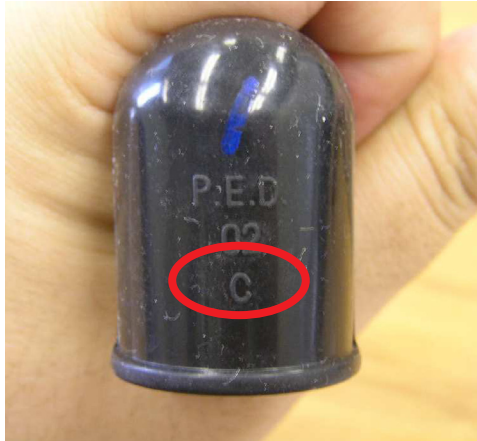
The high tension cables for Impreza and Forester have changed to a silicone rubber boot which has a shiny appearance. Please note that the part numbers have not changed. The Legacy and Outback high tension cables also have a silicone rubber boot.

New Style (C)

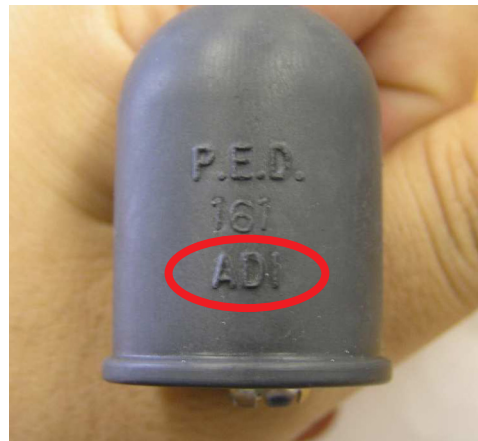
Old Style (ADI)
