SERVICE BULLETIN

APPLICABILITY: 2013-14MY BRZ

NUMBER: 07-79-13R

SUBJECT: Countermeasures for Frozen Power Windows

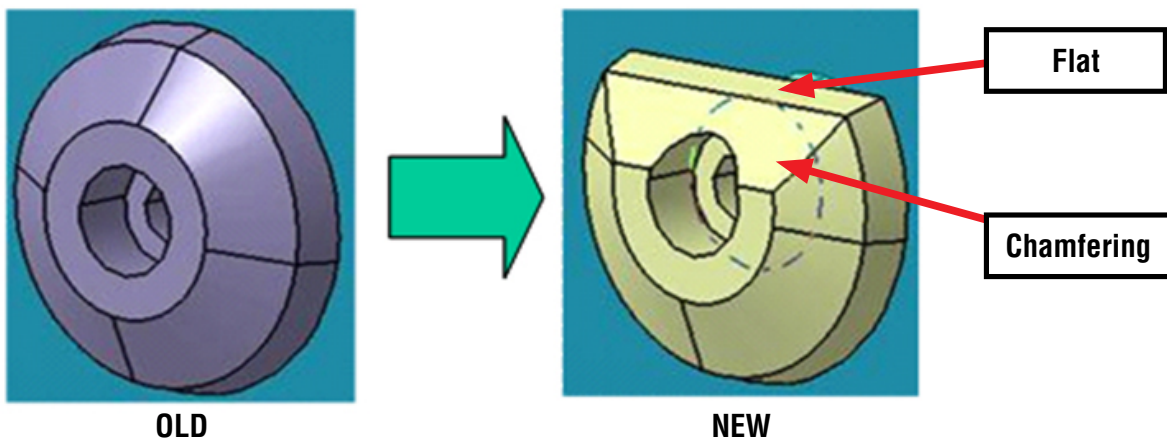
- A revised, hallow-type outer weatherstrip is used if the nap (fuzzy) portion has been pulled away from the rubber after freezing to the outside of the door glass.
- A change has been made to both of the power window switches which decreases the distance (stroke) of when the door glass lowers from 20mm to 10mm during the indexing function. The indexing function is controlled by an input from the outer door handle to the BIU which lowers the door glass slightly to clear the drip rail.
- A change has been made to “guide door lifter” to prevent a rattling noise which may occur as a result of the decreased index function door glass stroke.

IMPORTANT: The guide door lifters **must** be replaced at the same time the countermeasure power window switches are installed. See the comparison illustration below.
