## SERVICE BULLETIN

**APPLICABILITY:** 2016MY WRX and STI Models **NUMBER:** 07-99-15  
**SUBJECT:** Reprogramming File Availability for Keyless Buzzer Volume **DATE:** 10/26/15

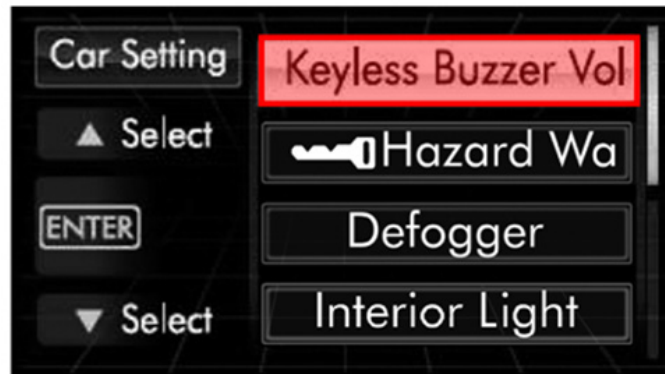
On some vehicles, a customer may not be able to access the “Keyless Buzzer Volume” function on the Multi-Function Display (MFD). This bulletin announces availability of reprogramming files for the Body Integrated Unit (BIU) to facilitate setting the volume of the keyless buzzer via the MFD.
