NUMBER: 08-020-17

GROUP: Electrical

DATE: February 25, 2017

Flash: Hands Free Module (HFM) Enhancements

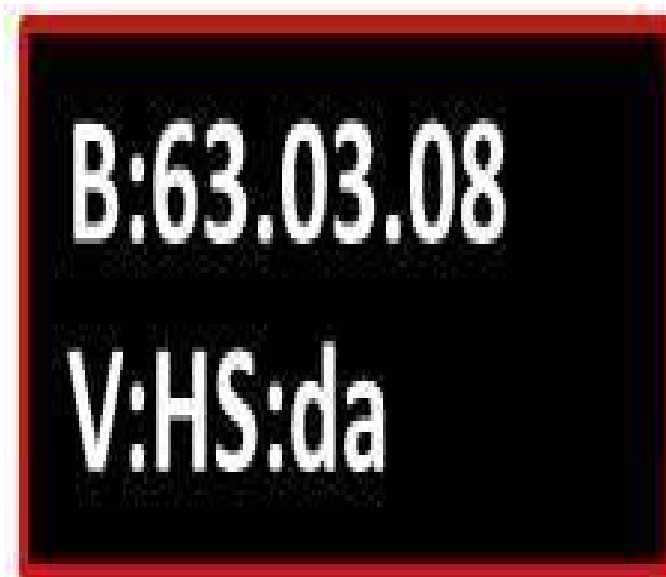
Fig. 1 Software Versions A

10. After hearing the beep, say "Setup-Software Update".
11. The HFM software version will now be displayed on the radio display screen.
12. Is the software version one of the following:
 - a. For Wrangler, Grand Caravan, Town & Country, Grand Cherokee and Durango with **Sales Code RSP** radios at B:63.03.08 / V:HS:da ([Fig. 1](#))?

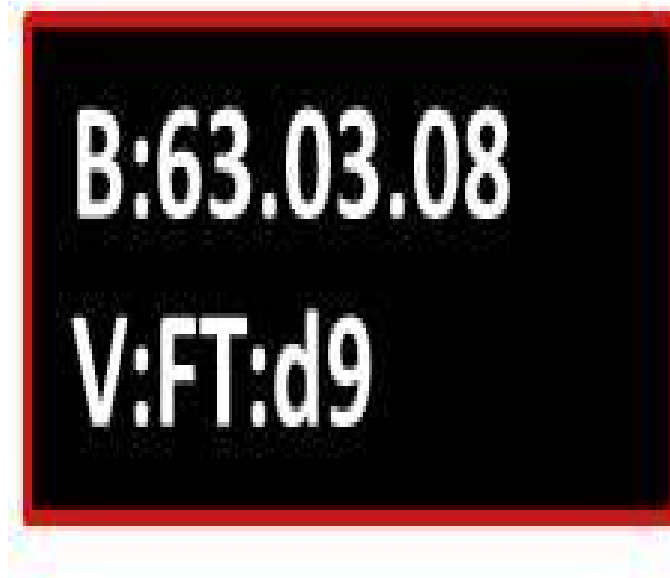
Fig. 2 Software Versions B

- b. For Patriot, Compass, Avenger, 200 and Challenger with **Sales Code RSP** radios at B:63.03.08 / V:FT:d9 ([Fig. 2](#))?

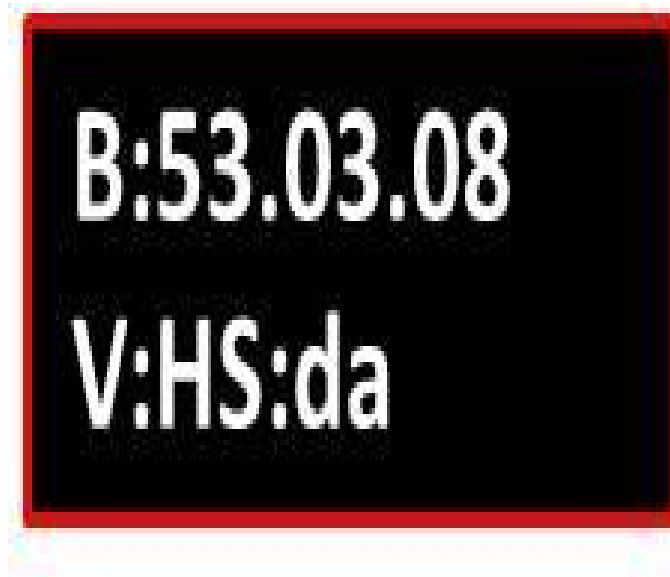
Fig. 3 Software Versions C

- c. For Wrangler, Grand Caravan, Town & Country, Grand Cherokee and Durango with **Sales Code RSQ** radios at "B:53.03.08 / V:HS:da (Fig. 3)?

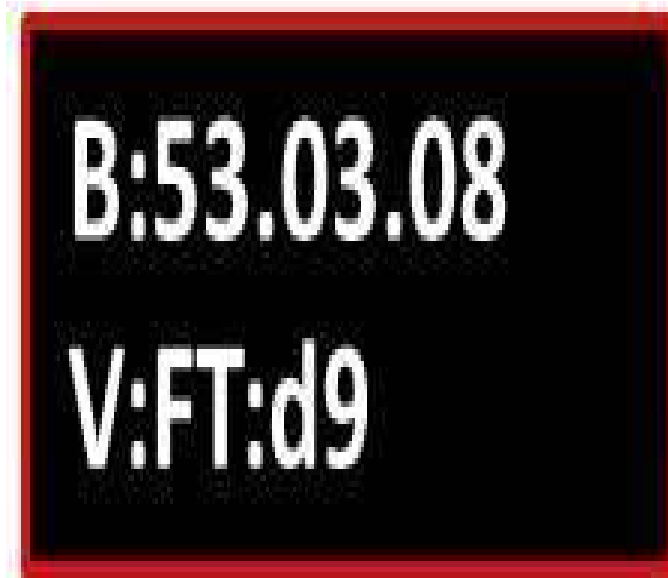
Fig. 4 Software Versions D

- d. For Patriot, Compass, Avenger, 200 and Challenger with **Sales Code RSQ** radios at B:53.03.08 / V:FT:d9 (Fig. 4)?

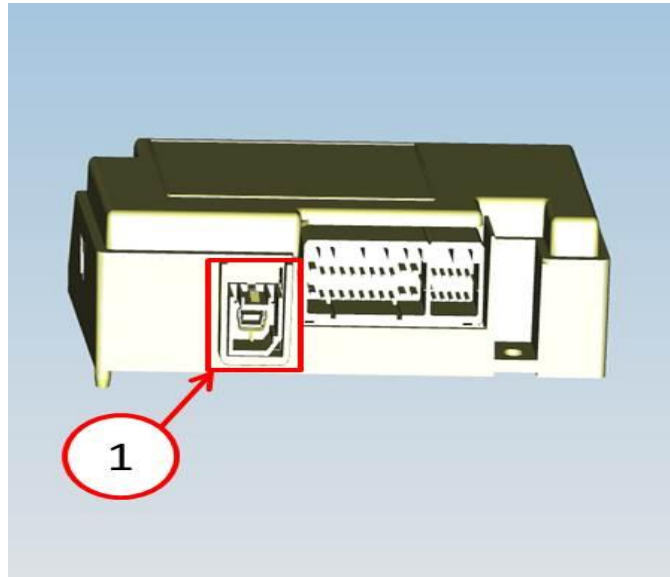
Fig. 6 USB Update Cable Port Location

20. Plug USB cable #68086985AB into the open port on the HFM (Fig. 6).

1 - Port to Plug USB cable #68086985AB into

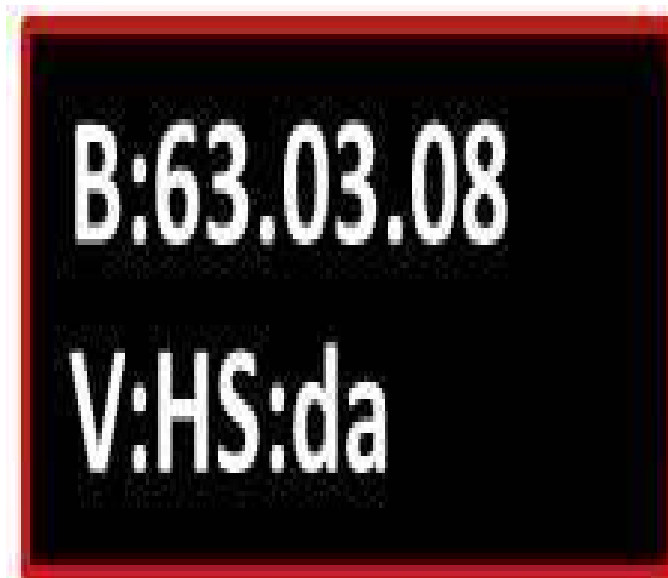
Fig. 7 Software Versions A

- 35. Is the software version one of the following:
 - a. For Wrangler, Grand Caravan, Town & Country, Grand Cherokee and Durango with **Sales Code RSP** radios at B:63.03.08 / V:HS:da ([Fig. 7](#))?

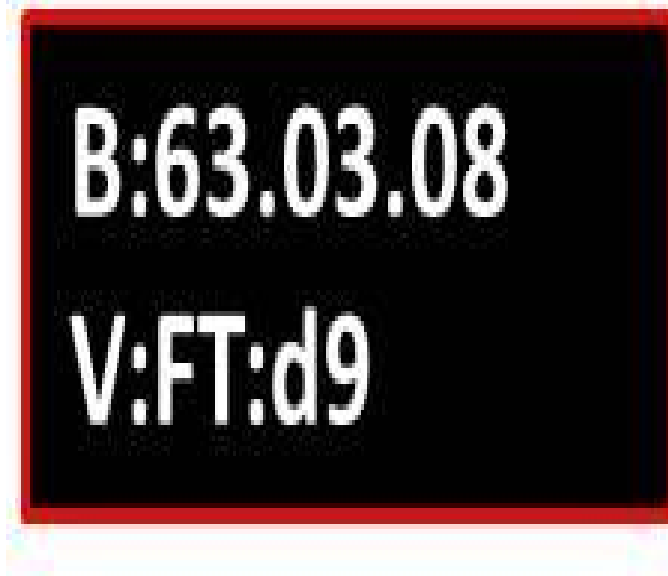
Fig. 8 Software Versions B

- b. For Patriot, Compass, Avenger, 200 and Challenger with **Sales Code RSP** radios at B:63.03.08 / V:FT:d9 ([Fig. 8](#))?

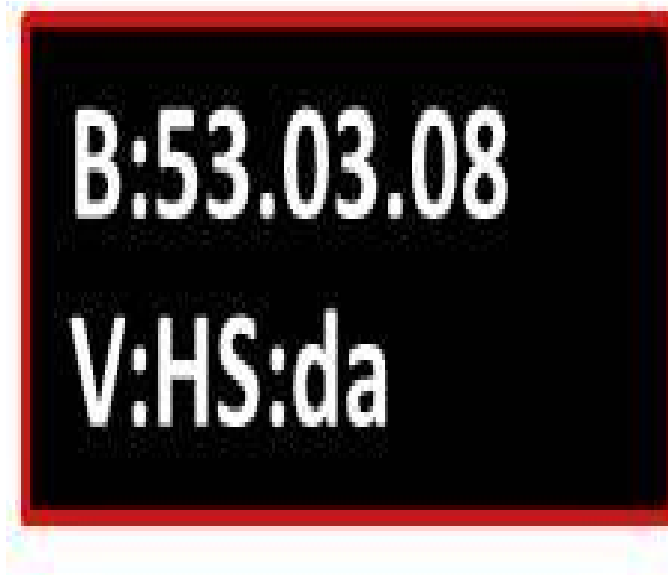
Fig. 9 Software Versions C

- c. For Wrangler, Grand Caravan, Town & Country, Grand Cherokee and Durango with **Sales Code RSQ** radios at "B:53.03.08 / V:HS:da (Fig. 9)?

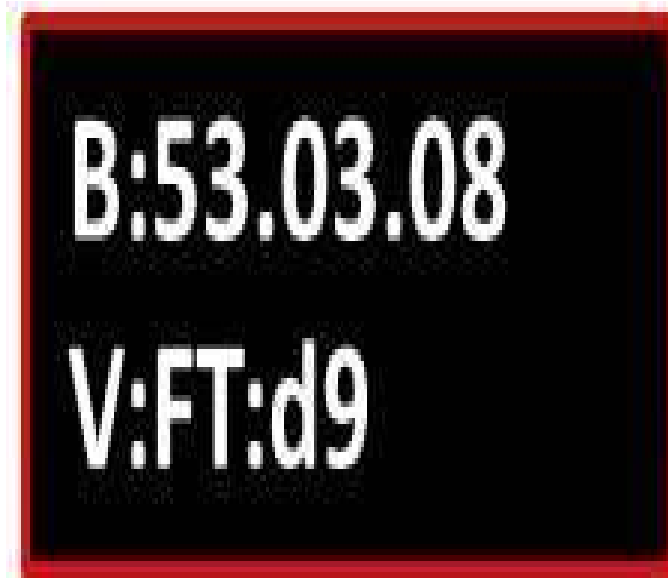
Fig. 10 Software Versions D

- d. For Patriot, Compass, Avenger, 200 and Challenger with **Sales Code RSQ** radios at B:53.03.08 / V:FT:d9 (Fig. 10)?
