NUMBER: 08-028-16 REV. A

GROUP: Electrical

RE2 RE6 RB5 RB6 Radio Software Enhancements

2013 - ****2016**** (PF) Dodge Dart

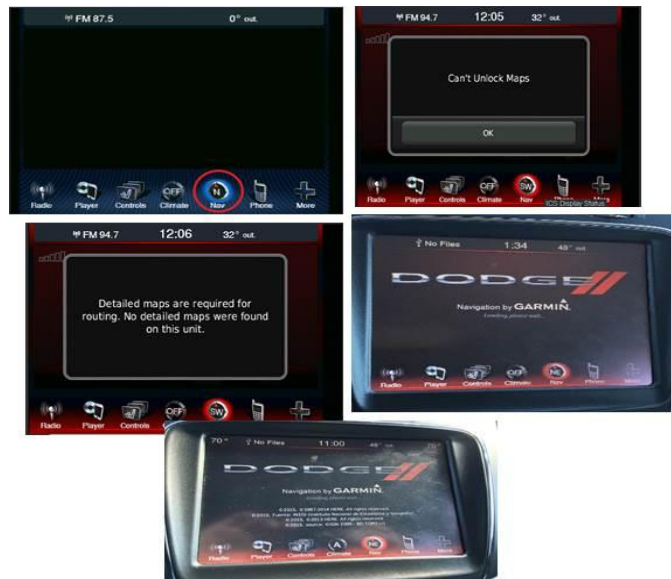
Fig. 1 Radio Display Screens

1. Start the vehicle, turn the radio on and allow it to power up.
2. Does the vehicle have one of the following navigation radios, RB5 or RB6?
 - a. Yes >>> Proceed to [Step #3](#).
 - b. No >>> Proceed [Step #6](#).
3. Press the navigation screen button and attempt to access the navigation main menu system.
4. The radio display may be stuck on one of the following screens: ([Fig. 1](#)).
 - Loading please wait.
 - Display screen black.
 - Can't unlock maps.
 - No detailed maps were found.

5. Is the radio display stuck on one of the screen listed above?
 - a. Yes >>> The radio will have to be replaced. Replace the radio using current electronic exchange center stock following normal warranty repair procedures. Refer to published service information in Tech Connect Section 08 - Electrical/8E - Electronic Control Modules/Module, Telematics Gateway/Removal. No further action is required, the bulletin is now complete. The replacement radio will contain the latest software update.
 - b. No >>> Proceed to [Step #6](#) and perform the software update.

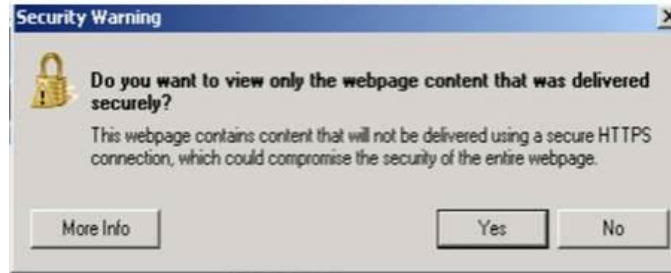
Fig. 2 Pop-up Security Message

6. Has a USB flash drive been created with the current software update?
 - a. YES >>> Proceed to [Step #11](#).
 - b. NO >>> Proceed to [Step #7](#).
7. Go to DealerCONNECT>Service>UCONNECT Information & Utilities> Uconnect Dealer software downloads to download the files.
8. If a security message appears “Do you want to view only the webpage content that was delivered securely?” See ([Fig. 2](#)). Press **No** to continue.

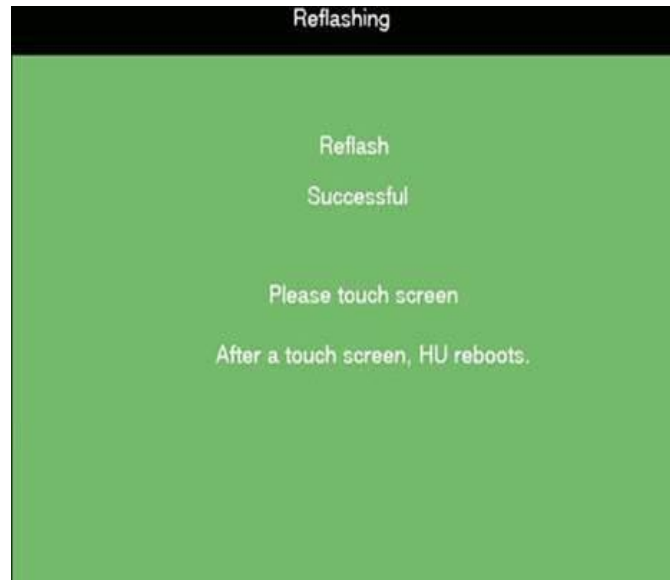
Fig. 3 Touch Screen Instruction

16. When the update is completed, the screen will read “Reflash Successful”. Remove the USB flash drive and touch the screen anywhere to initiate the radio to reboot. See (Fig. 3).

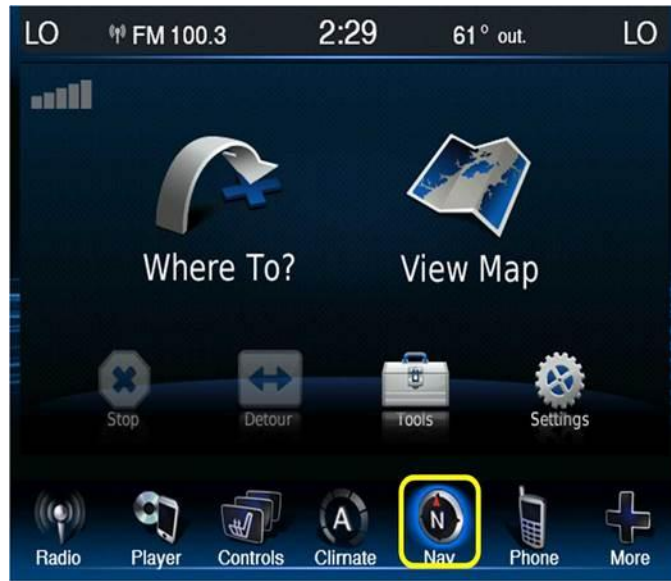
Fig. 4 Nav Screen Icon

20. Press the Nav icon on the radio screen to enter the navigation system main menu.
See (Fig. 4).

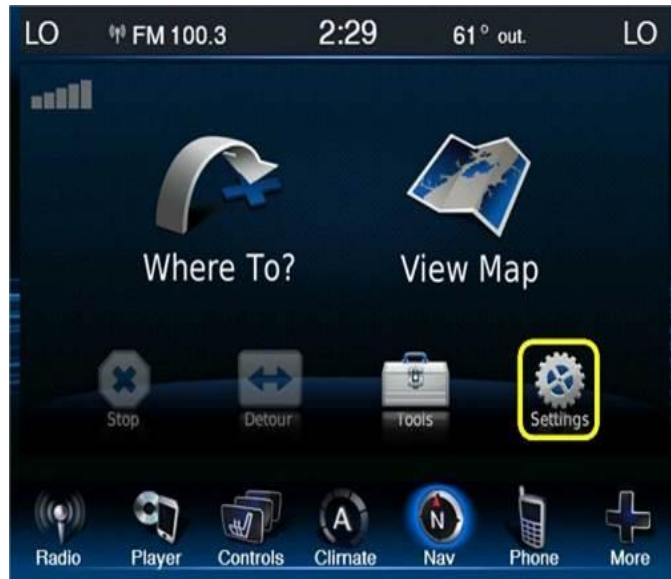
Fig. 5 Settings Screen Icon

21. Press the Settings Icon. See (Fig. 5).

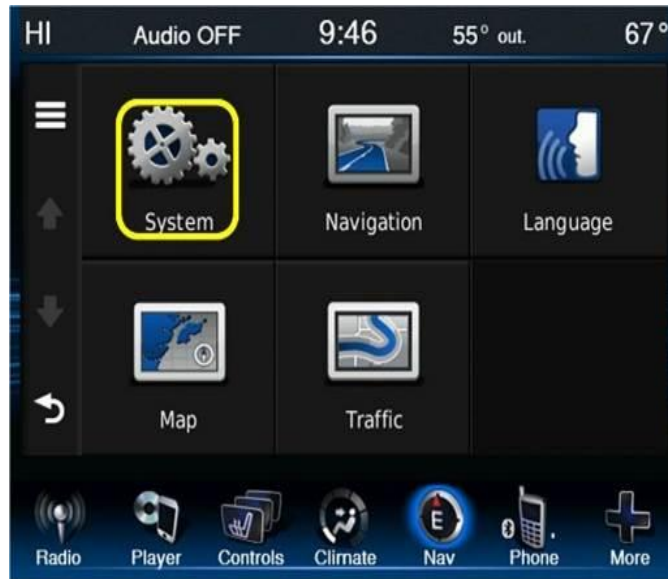
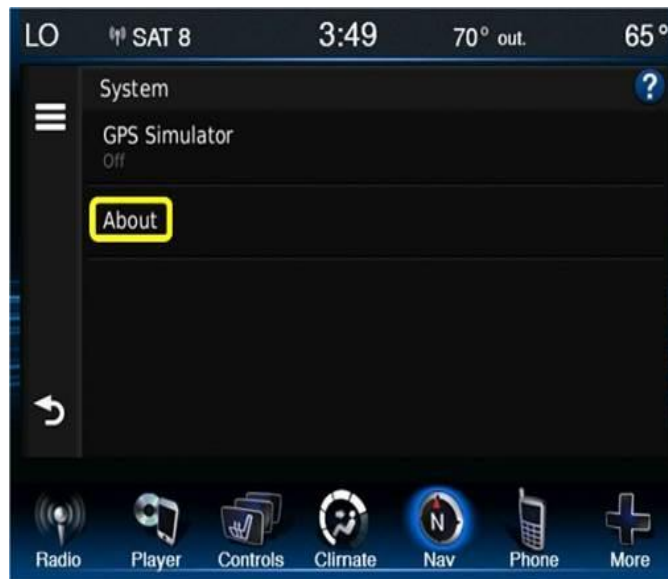
22. Press the System Screen icon and then the About icon to display the Garmin System Information. See (Fig. 6) and (Fig. 7).

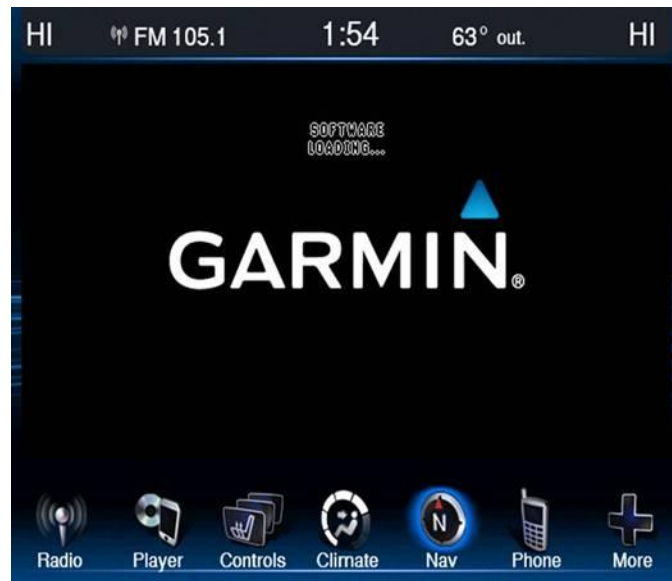
Fig. 8 Garmin Software Loading

26. Once the update has started the radio will change to the software loading screen. See (Fig. 8).

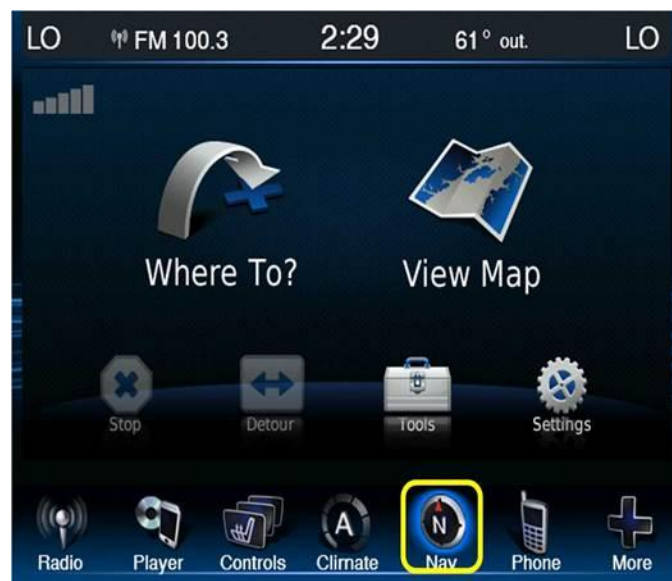
Fig. 9 Update Complete

27. Once the software update has completed downloading, the screen will automatically change to the Garmin main screen. See (Fig. 9).
